# Overflow tests on Dutch levees

Adaptation  
to climate  
change

## Overflow tests on Dutch levees

1.0 – 20221222

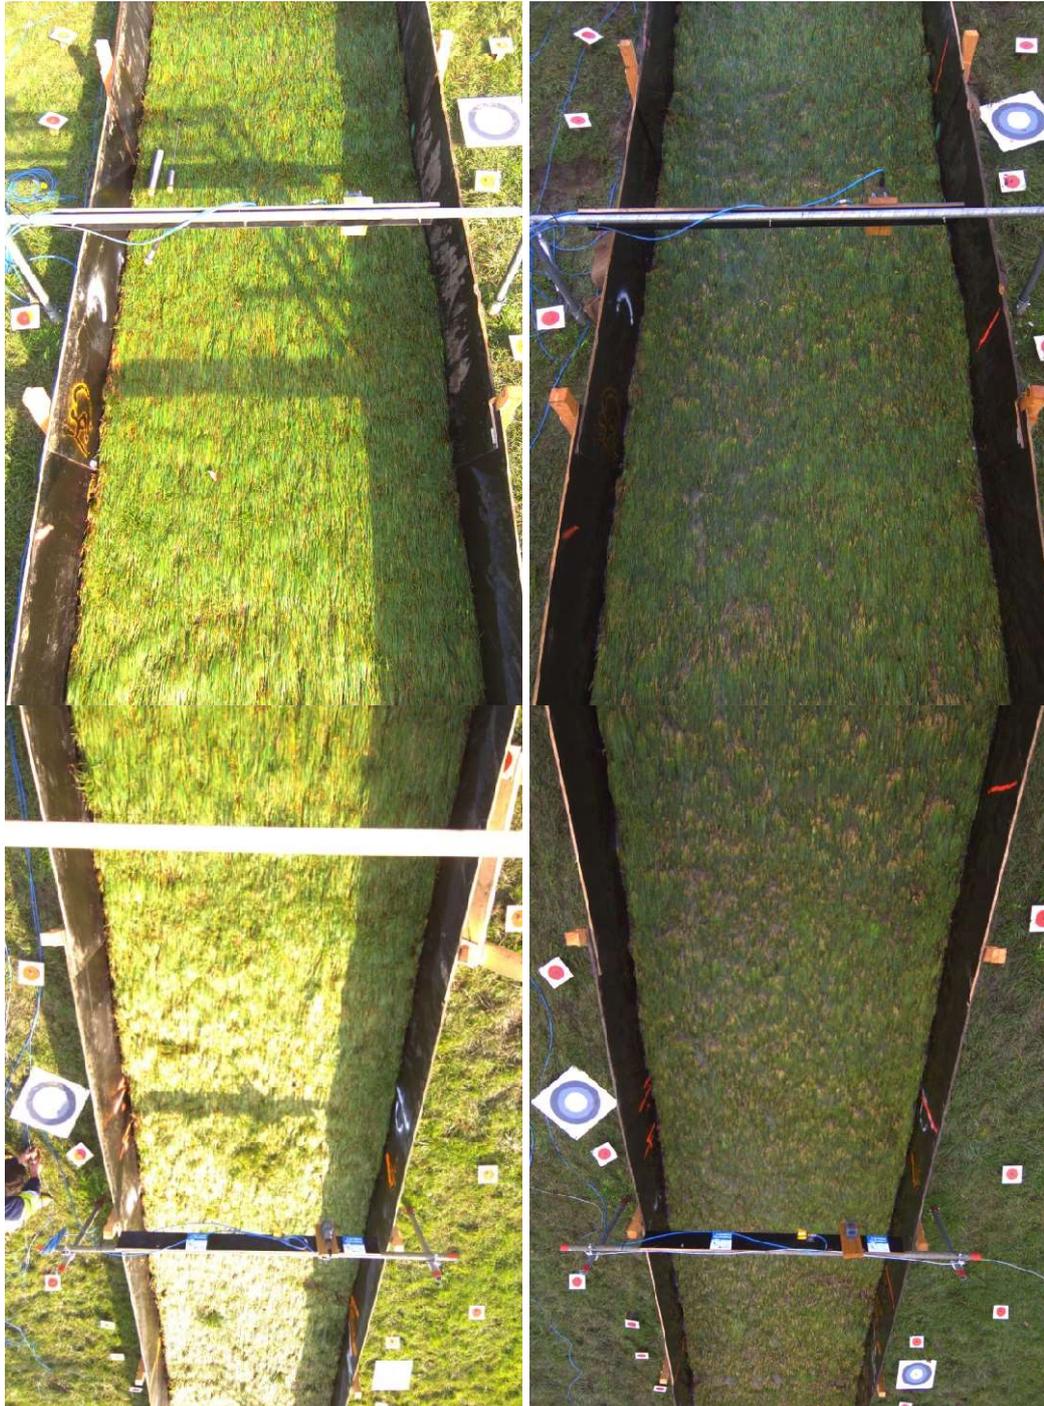
During the more than 30 hours of overflow, no noteworthy damage occurred. During the test, it was observed that soil eroded slowly and exposed grass roots, without creation of any significant damage that would lead to imminent failure of the levee slope. Near the levee toe edge, a drainage layer became exposed and some of the gravel that was part of that drainage layer, got washed away (visible on Figure 6). However, this did not lead to any critical damage. As already indicated above, the levee toe was not in a 'pristine' state due to crane and truck tracks.

Figure 7 - Images from the upper portal at N-OF01 block B0 and block B24.

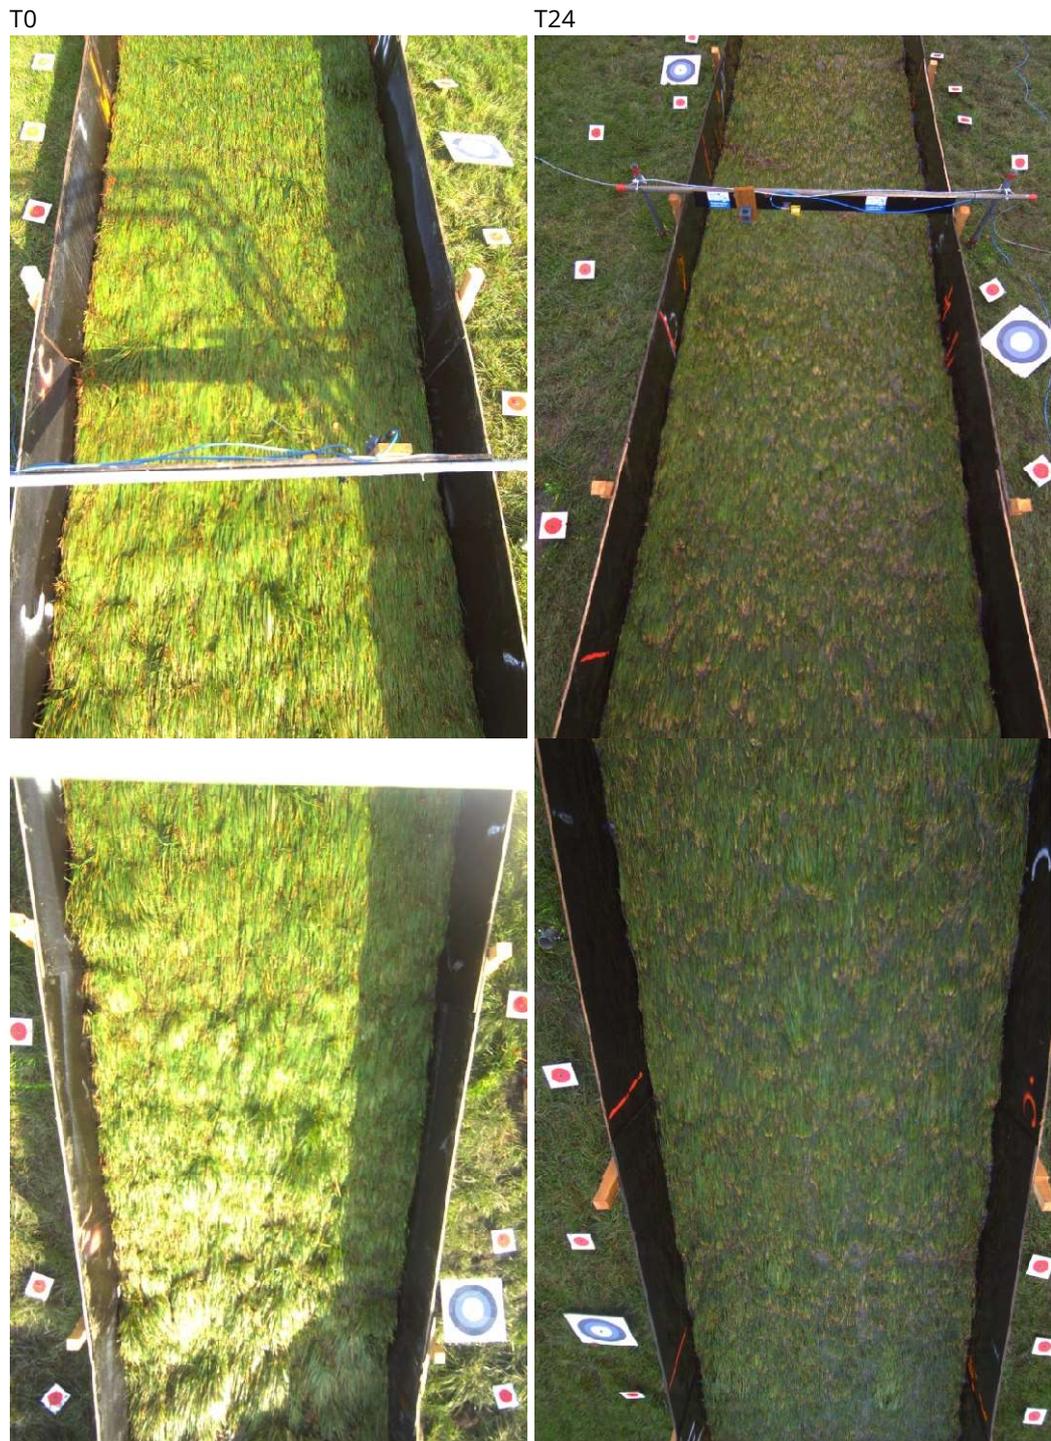
Figure 8 – Images from the lower portal at N-OF01 block B0 and block B24.

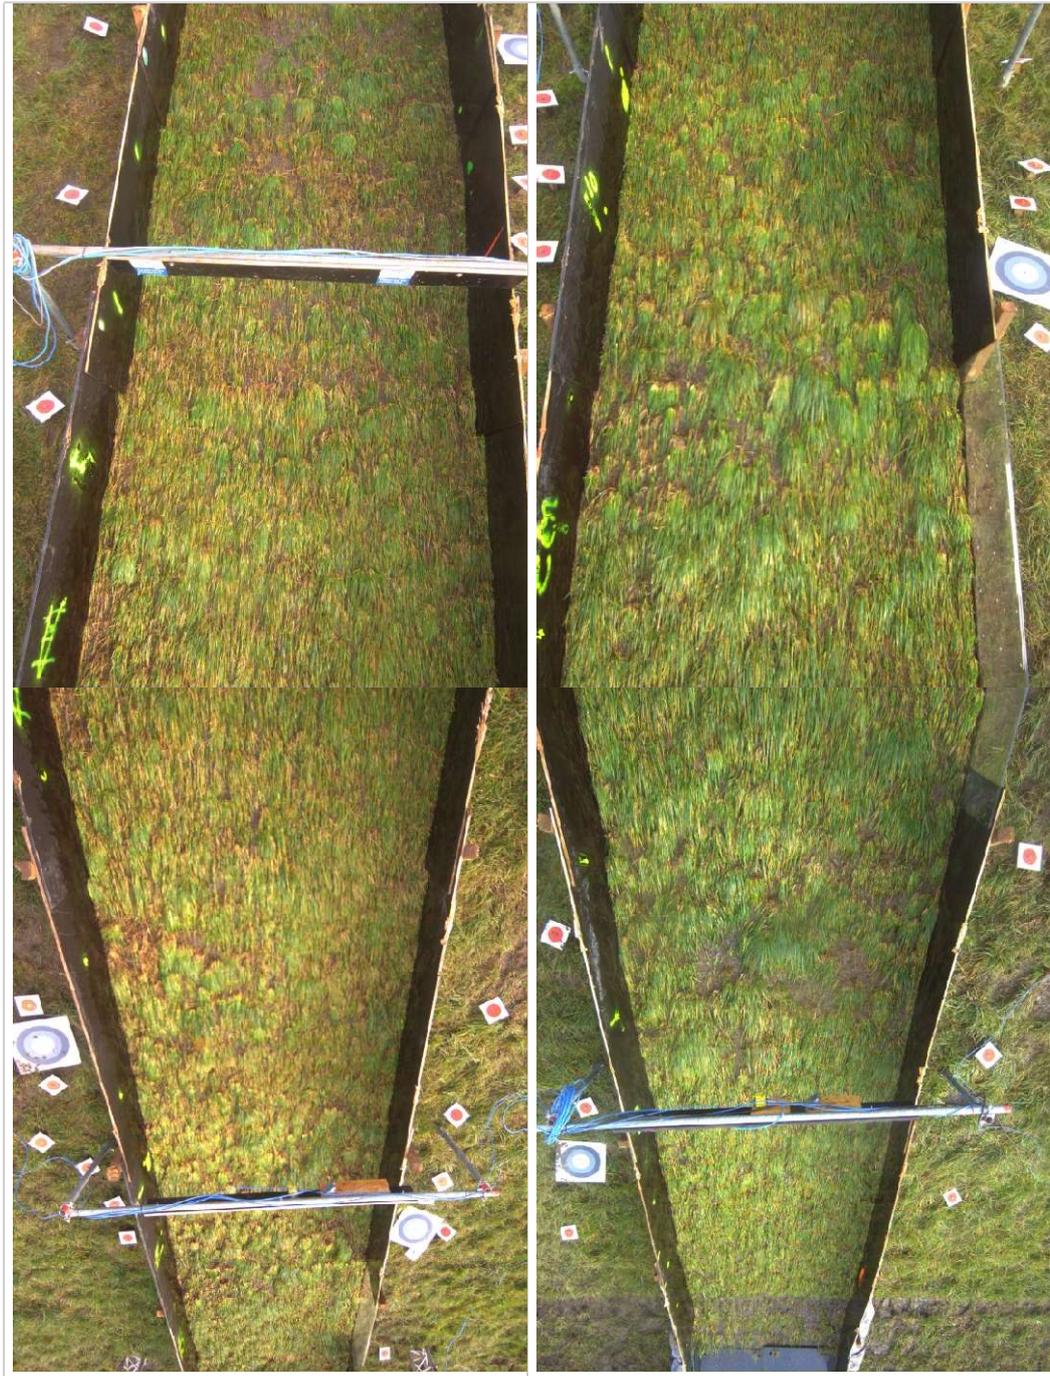
The experiment starts with a levee slope that is visually in a good state. However, after a first occurrence of overflow, it is observed that on the lower part of the slope, some vegetation is quite 'thin', or missing. This is visible on Figure 24.

Figure 24 – Levee state after 1 hour of overflow. Left are camera 1 and 2. Right are camera 3 and 4. levee crest is in the upward direction, levee toe is in the downward direction.

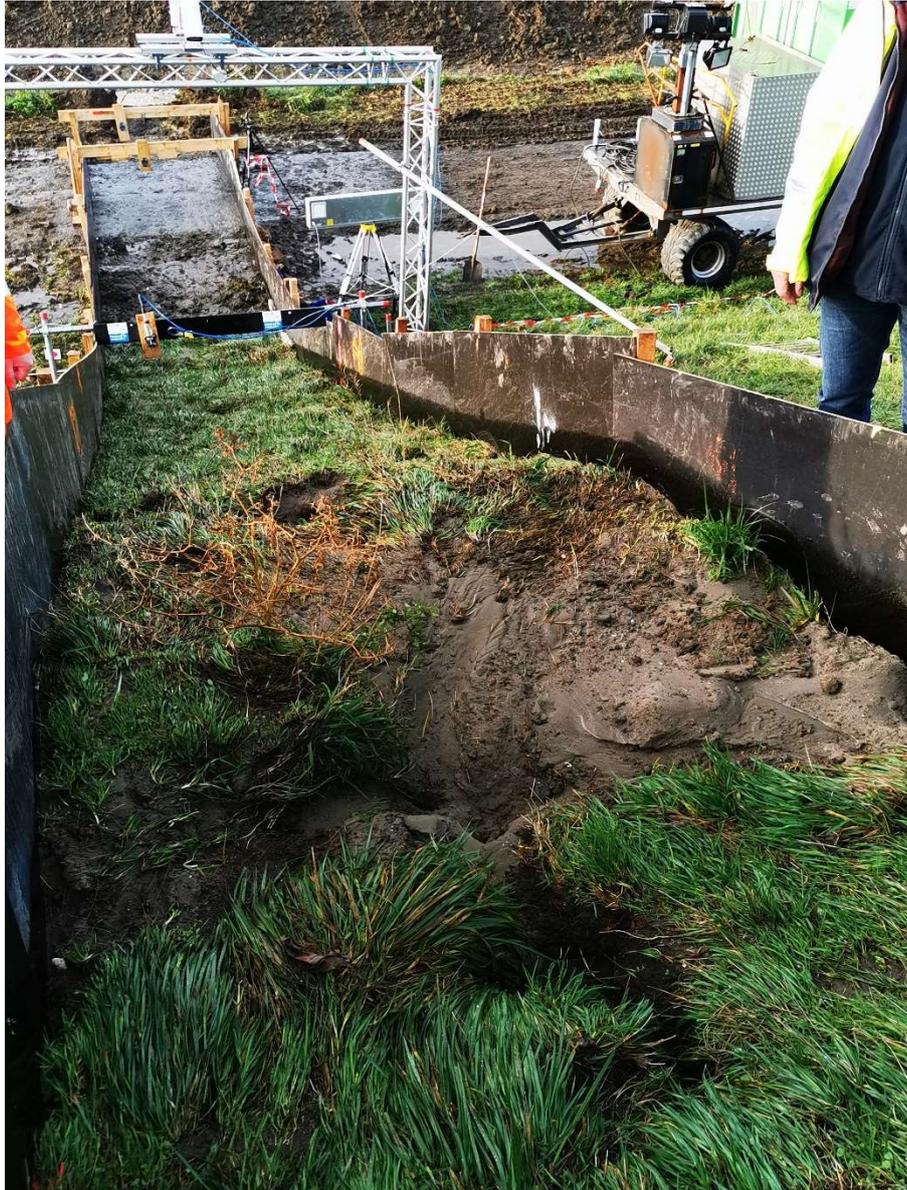
Figure 34 - Downward view of the rabbit burrow on the levee slope in N-OF05 prior to testing.

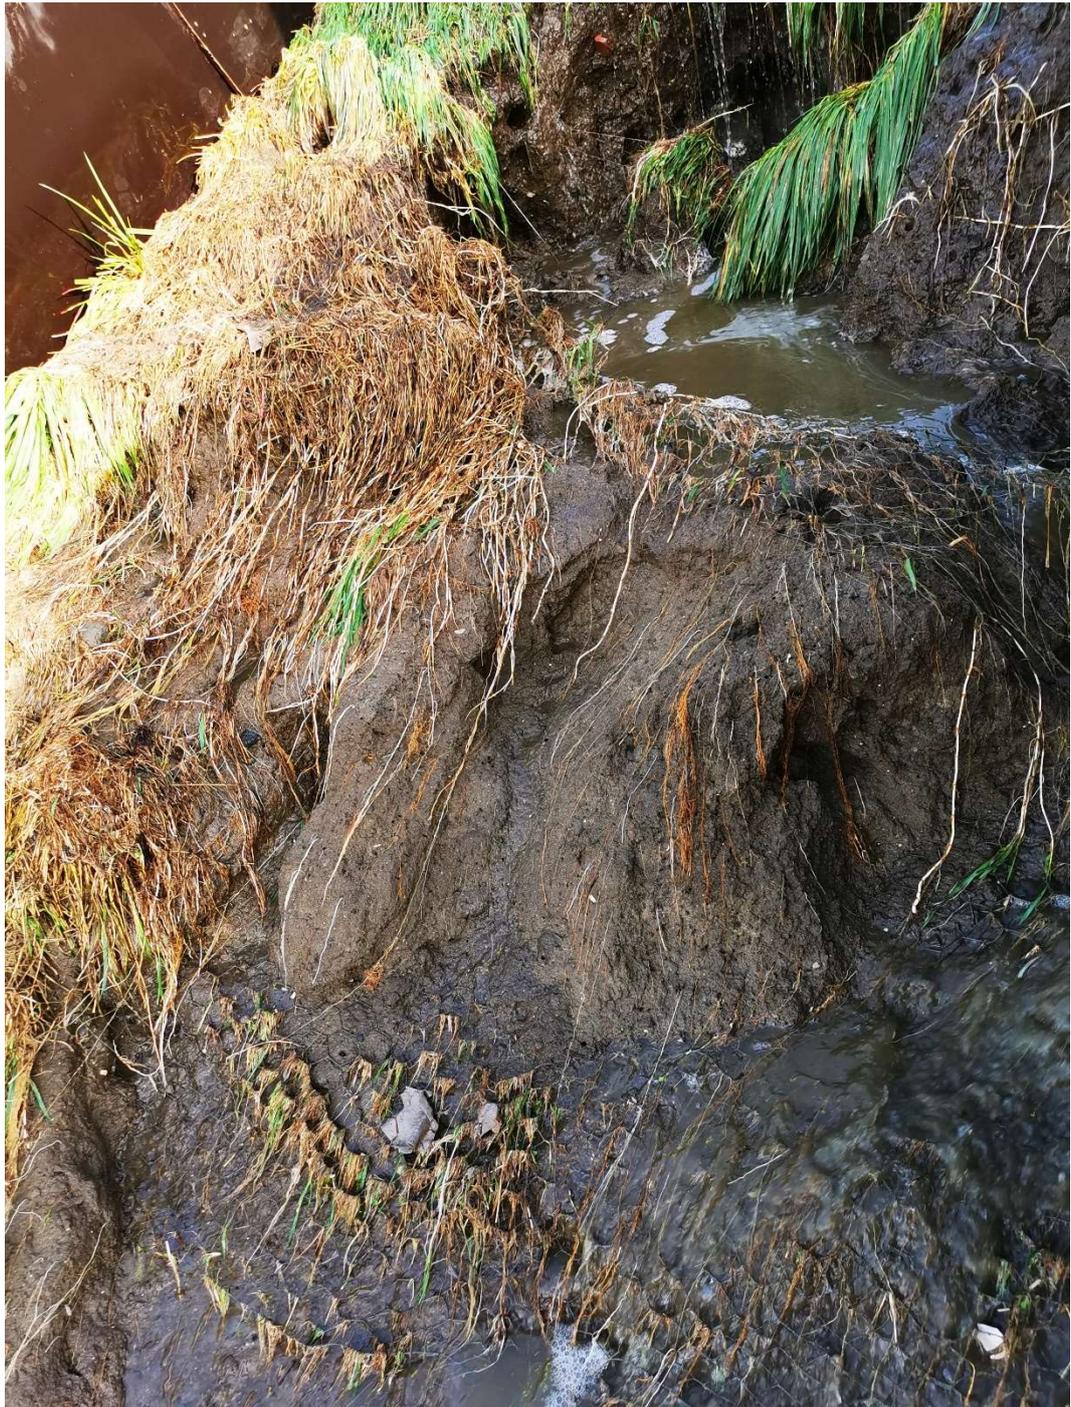
area, cutting into the cover layer (Figure 39). This developed continuously and a waterfall-like feature became present. The erosion became very outspoken after +/- 45 minutes into the test. Finally, after 1 hour and 13 minutes, the test was ended because the cliff that had developed suddenly destabilized and gave rise to a large slope failure. During the minutes that followed, it was observed how the head scarp migrated another 2 meters upwards (Figure 40).

Figure 39 - Erosion ongoing: at the bottom, soil somewhat stabilized by wire fence, an erosion pit upstream of it, at the base of a small cliff.

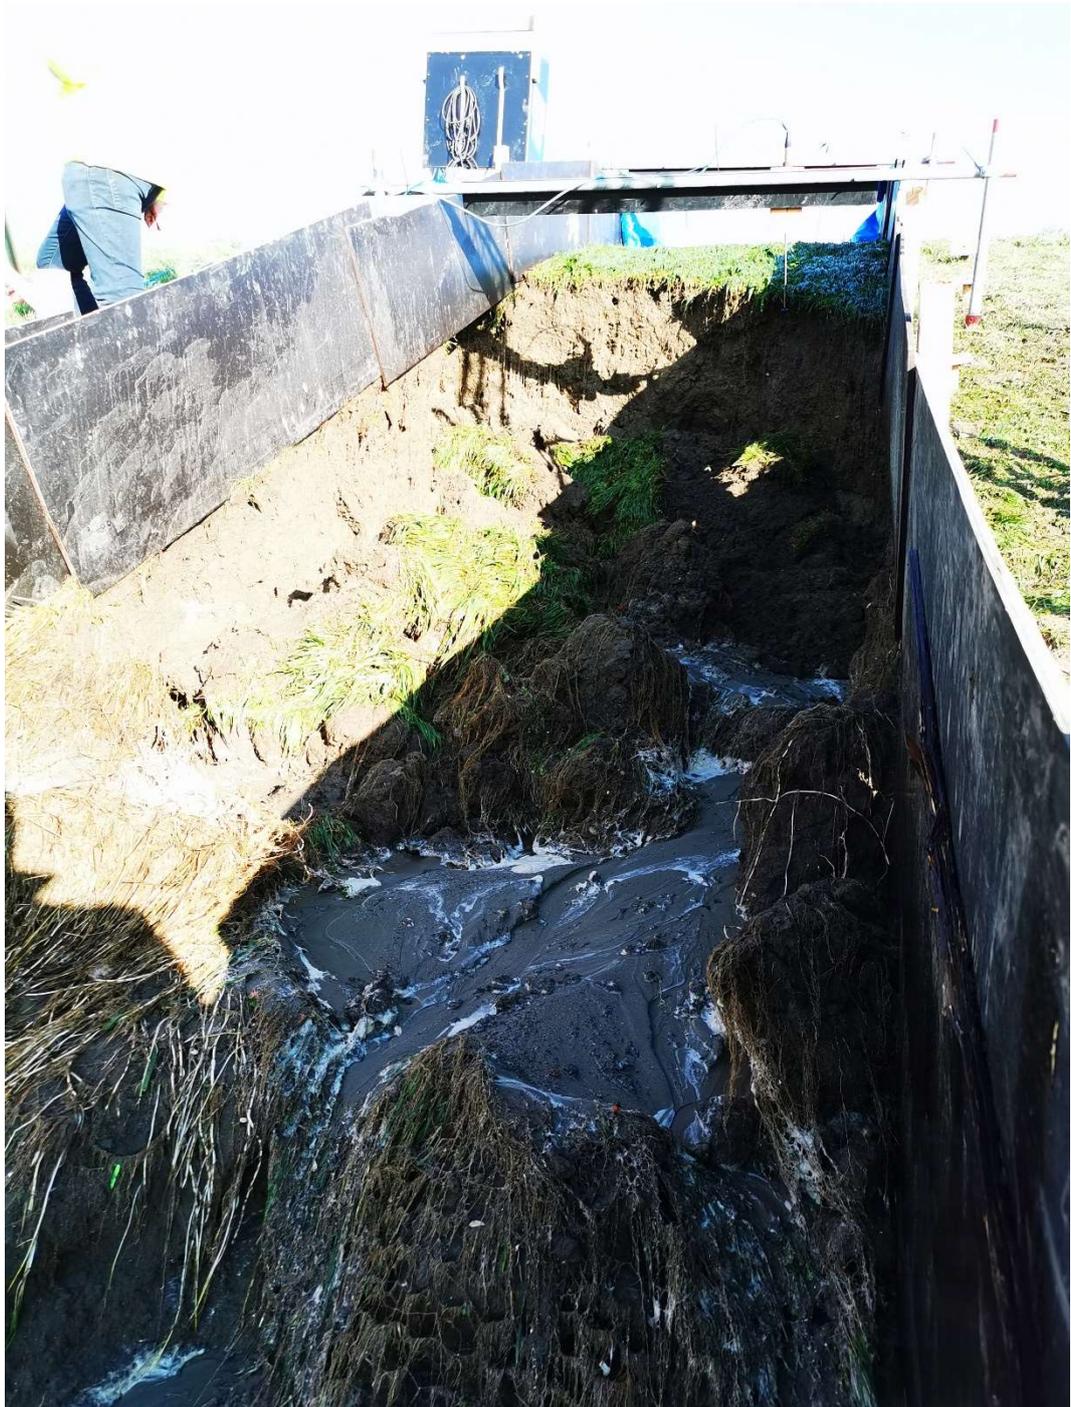
Figure 40 - Outcome of the test: within minutes, the damage evolved into a large instability.

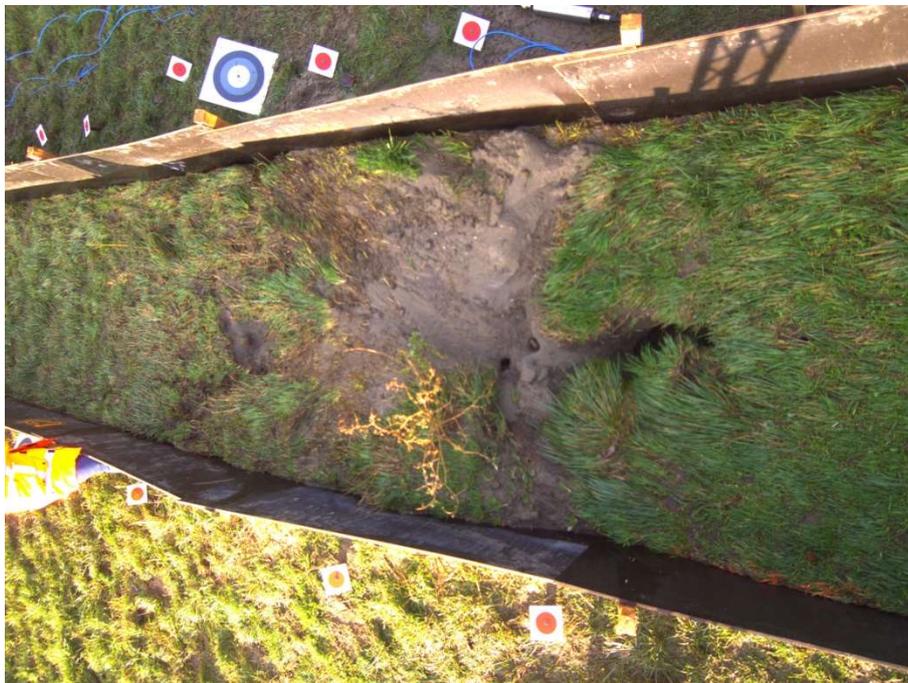
Figure 41 shows the initial state of the burrow. In front (downward) of the burrow entrance, a mound of sand can be observed, without any vegetation. The burrow entrance is about 20 cm wide and will thus easily allow water to infiltrate the levee.

Figure 41 - Initial state of the burrow.

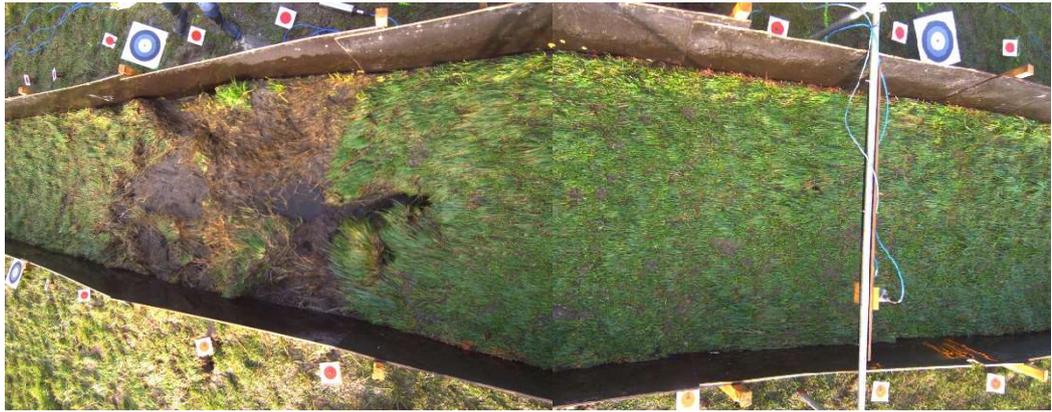
Figure 42 - Composed image of the burrow area after the sand mound has been eroded (B1).

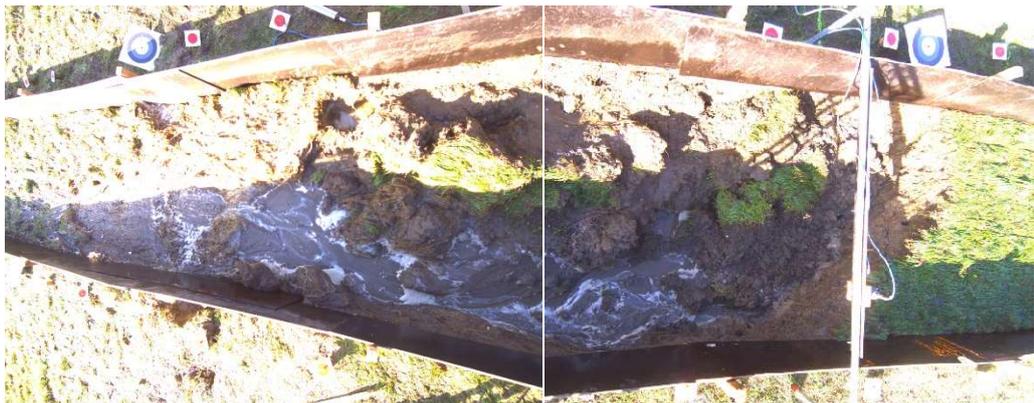
Finally, Figure 44 shows the end state: the damaged area extends several meters upwards from the original burrow position. A large scarp has developed and this erosion cliff has migrated upwards several meters before stabilizing again.

Figure 44 - Composed image of the damaged area at the end of the experiment (B10).

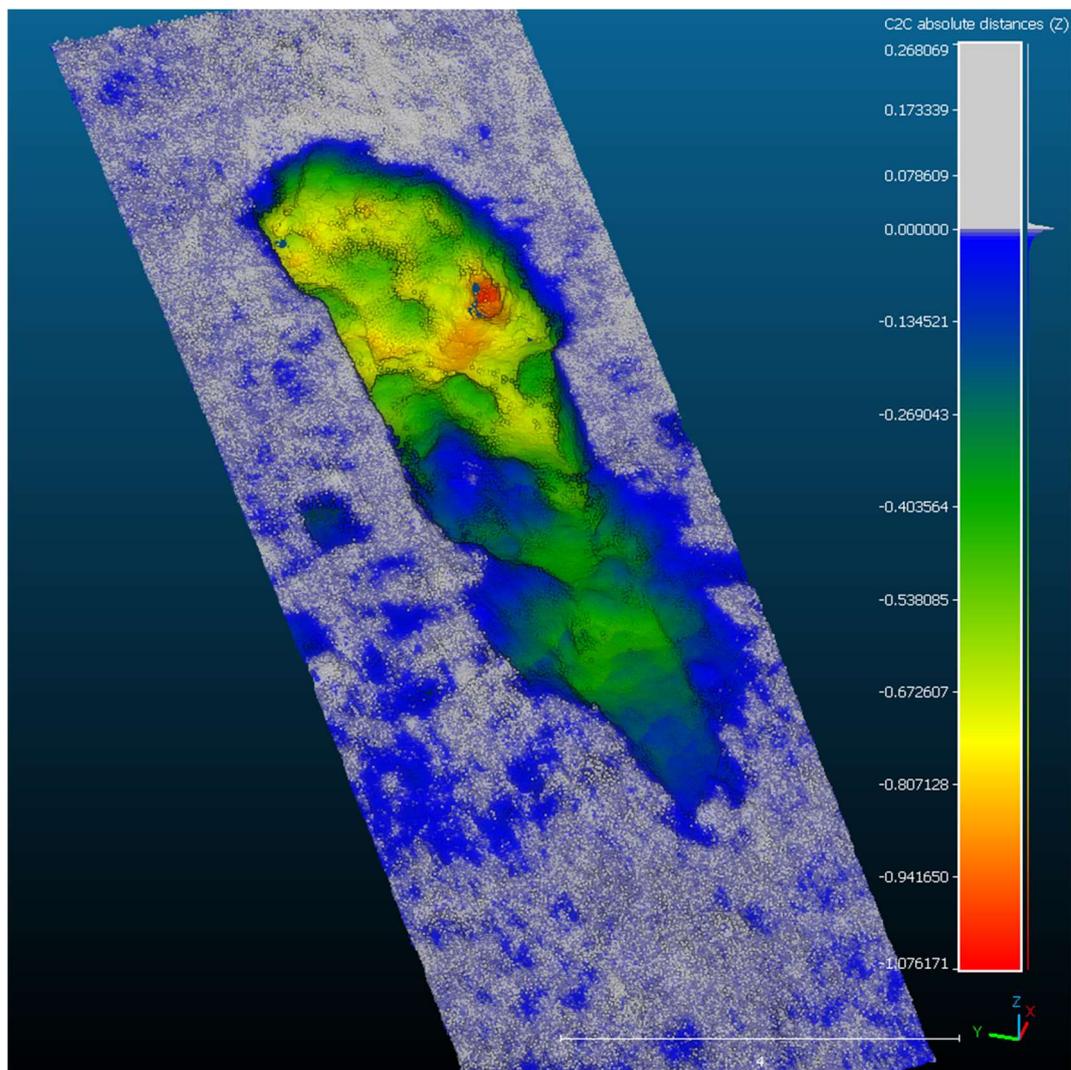
From the difference map T0-T1, it is clear that the deepest erosion is 1.07 m, but in general, the erosion depth is 0.2 to 0.8 m (Figure 47).

Figure 47 - 3D view of the height difference between the T0 and T1 measurement.

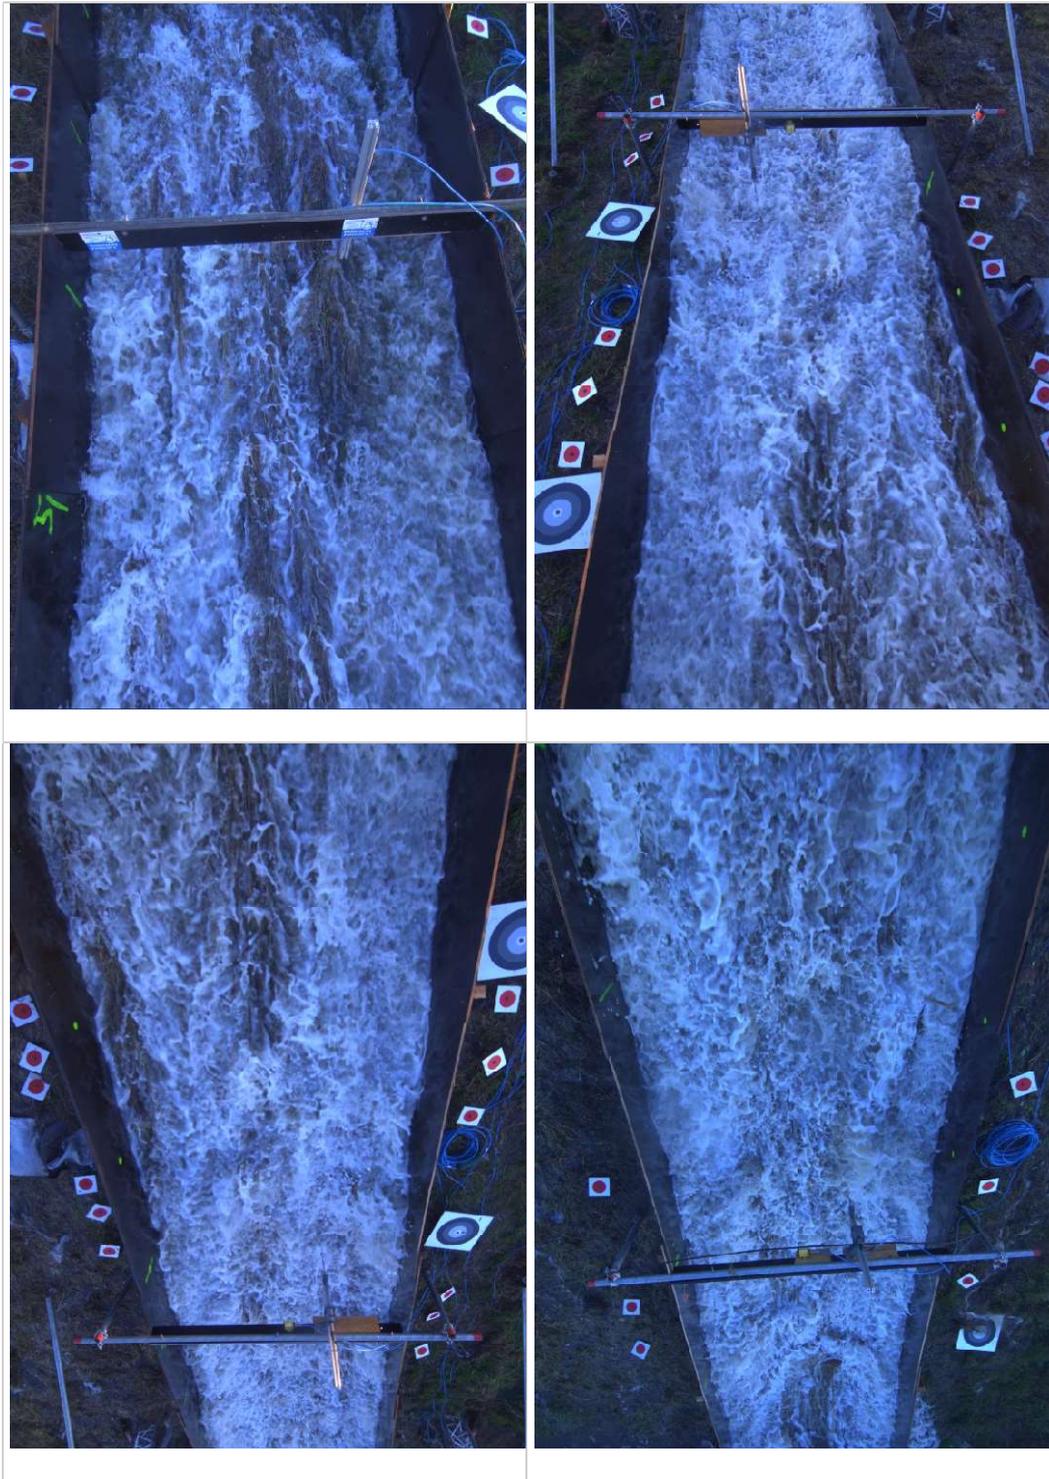
During Block B01, images have been collected in order to visualize the current patterns. An example is shown in Figure 54. The flow pattern appears to be very irregular, which is caused by the flow under the RTM solution.

Figure 54: Flow pattern during the overflow test N-OF06. Left: camera 1 and 2; Right: camera 3 and 4.

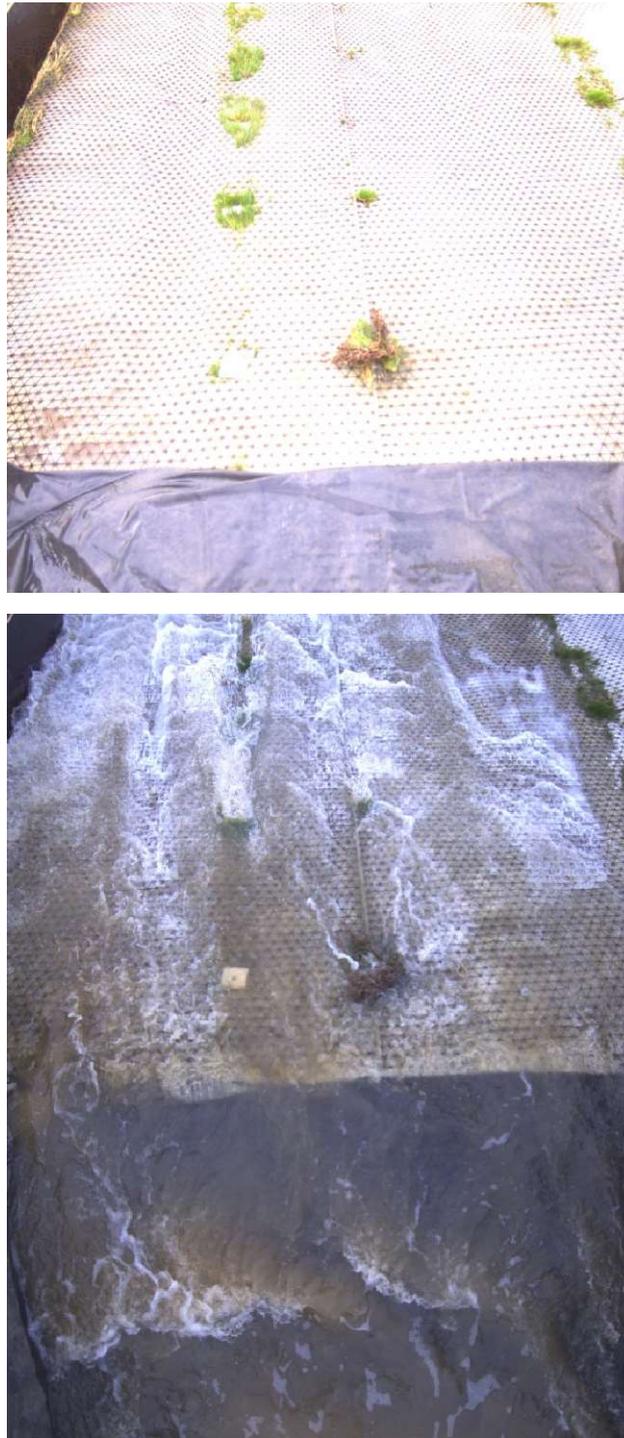
- The geogrid as a RTM solution is "transparent" to the flow of water and thus does not protect the underlying soil from erosion. Geen instant sterkte!
- The installation of the RTM solution by crane driving perpendicular to the crest line, up and down the slope, is not a suitable technique for this purpose.

Figure 59 - Illustrations of the RTM solution at N-OF07 before and during overflow..

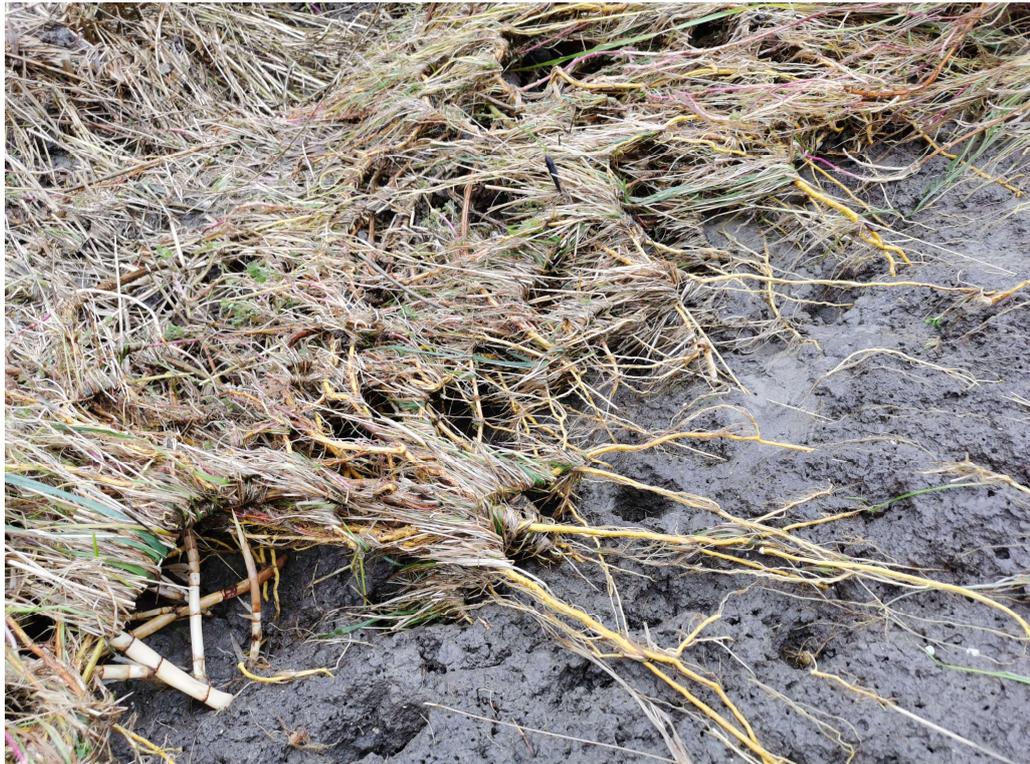
Figure 75: Image of the vegetation roots exposed where soft soil has eroded.

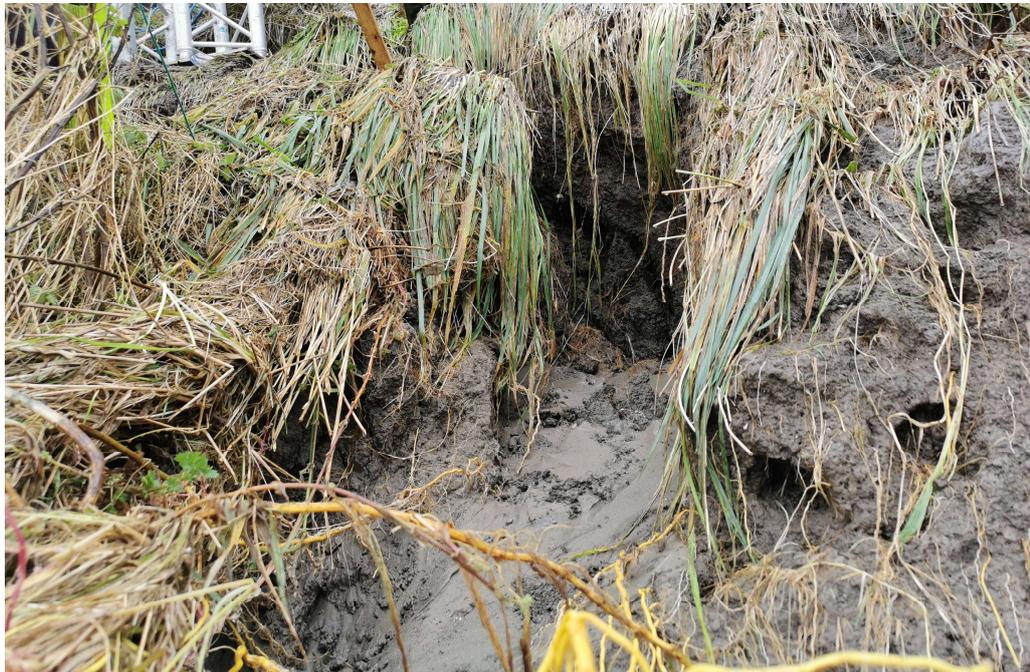
Figure 76: Erosion down to the sand core of the levee.

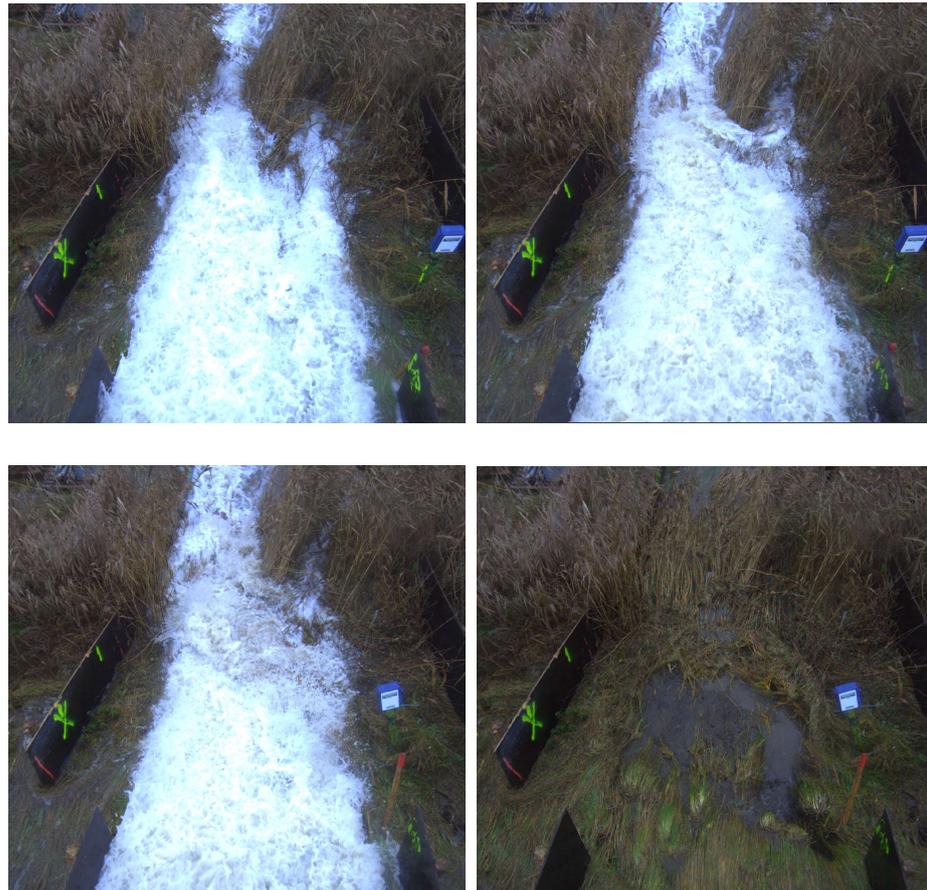
Figure 78: Evolution of damage at N\_OF10 at 12:04 (top left), 12:30 (top right), 12:38 (bottom left, note the tilted sensor box) and 12:40 (bottom right, at the end of the overflow).

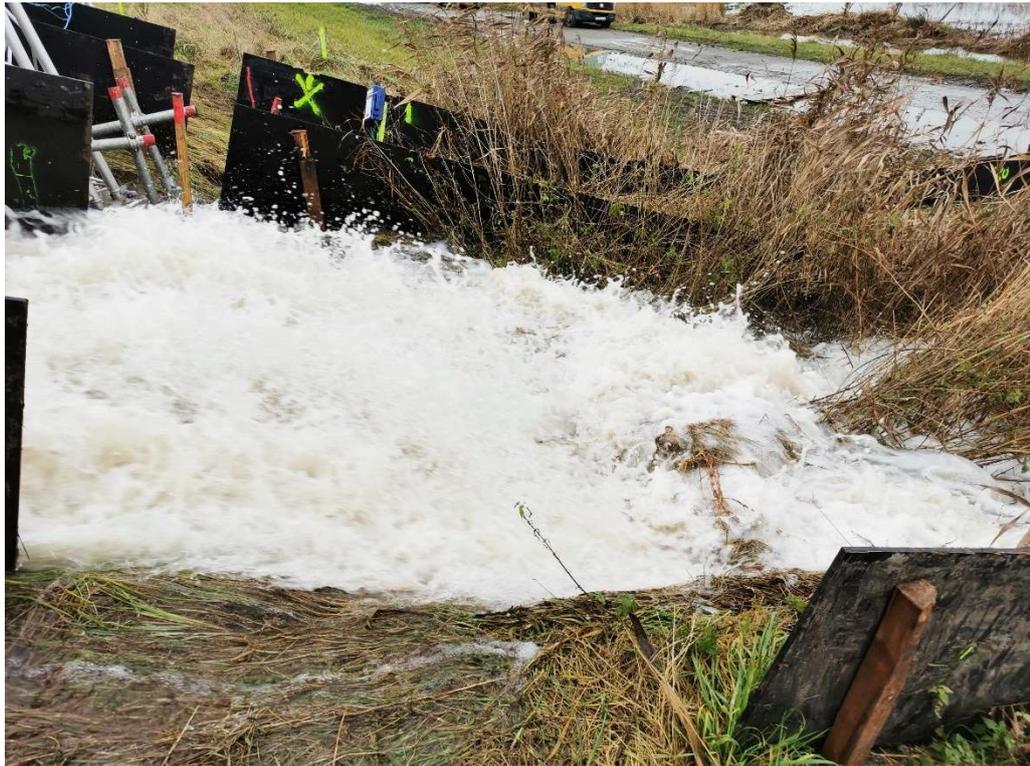
Figure 84: Impact of the overflow onto the reed path – note that the root is increasingly being exposed.
