COASTAL EROSION ON THE CARIBBEAN COAST

Examining an ever-changing beach in Costa Rica

An assessment of coastal erosion in Costa Rica

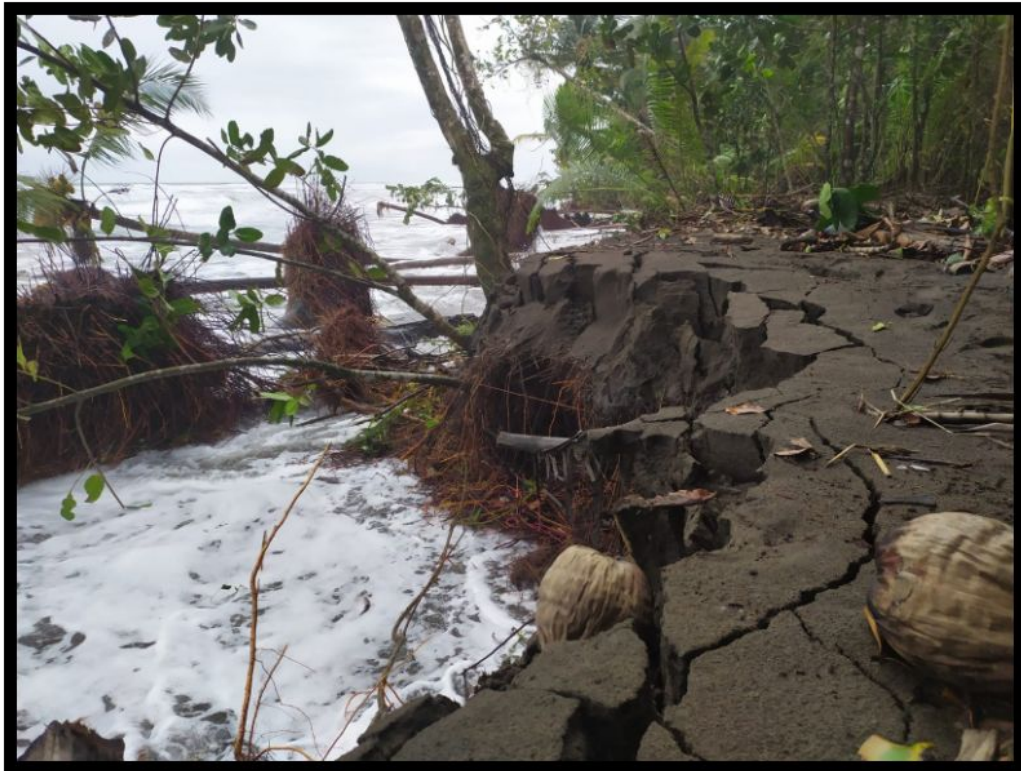
Figure 1: Heavily eroded coastline in Costa Rica, on a beach where turtles normally come to nest

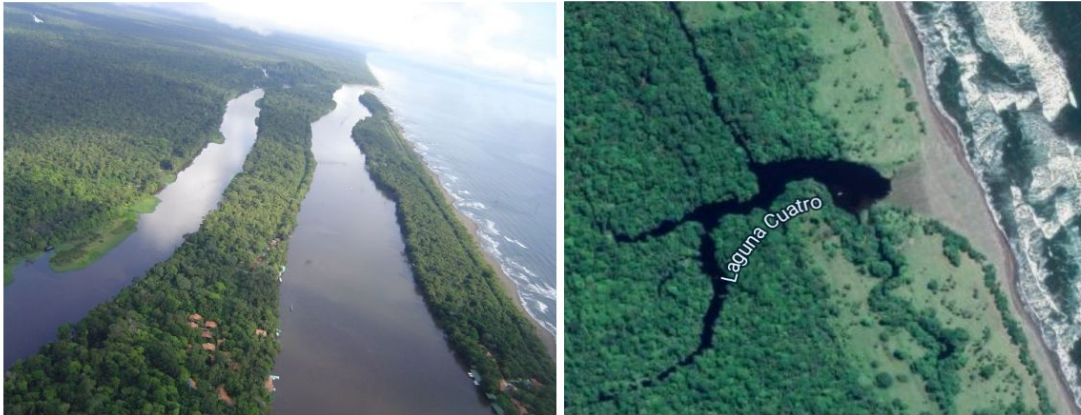
Figure 2: On the left, an aerial photo of the Tortuguero river, protected by the land strip. On the right, Laguna Cuatro, a spot at the end of playa Norte which will be one of the first major fresh water bodies to be in contact with the ocean due to erosion.

It is hypothesized that plant communities can play a major role in slowing coastal erosion. A study performed in 2013 proved that this is the case in dune landscapes (Kobayashi, Gralher & Do, 2013). However, various studies performed in habitats like wetlands and dunes suggest that plants that are maladjusted to saline stress will disappear at a high rate when exposed to sea water and coastal erosion (Feagan, Sherman & Grant, 2005; Chabreck, 1982). Plant communities can also be drastically altered in composition under influence of coastal erosion (Agir, Kutbay, Surmen & Elmas, 2017). These facts are worth looking into when one considers the vulnerable areas that are present near the Tortuguero river (Figure 2).

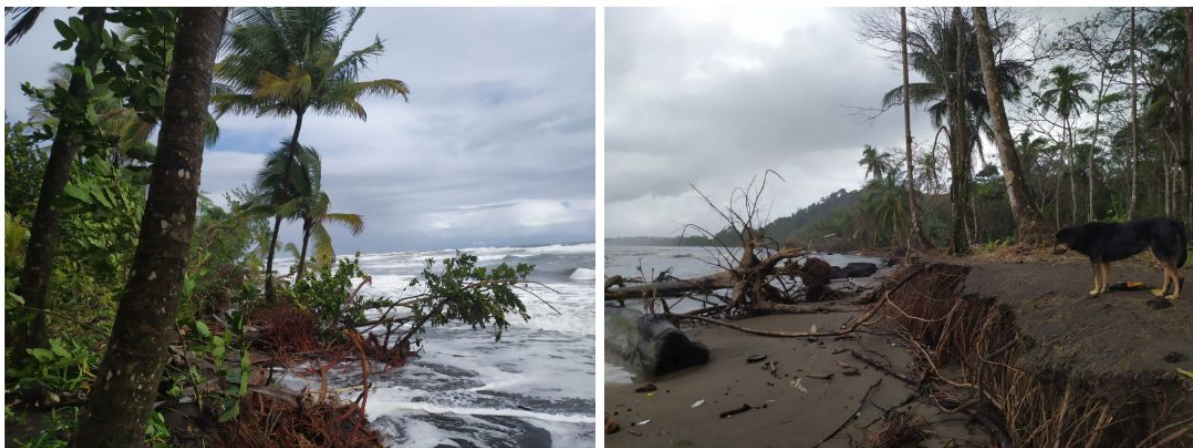
Figure 3: The effects of erosion at sites in playa Norte.

Researchers located in this area have noticed the effects of erosion for several years. In November 2019, the tropical storm Sebastien damaged large parts of the beach located in the northern coastal part of the area, called playa Norte. This initiated a rapid increase in erosion rate, resulting in devastating scenes at the beach as seen in Figure 3.

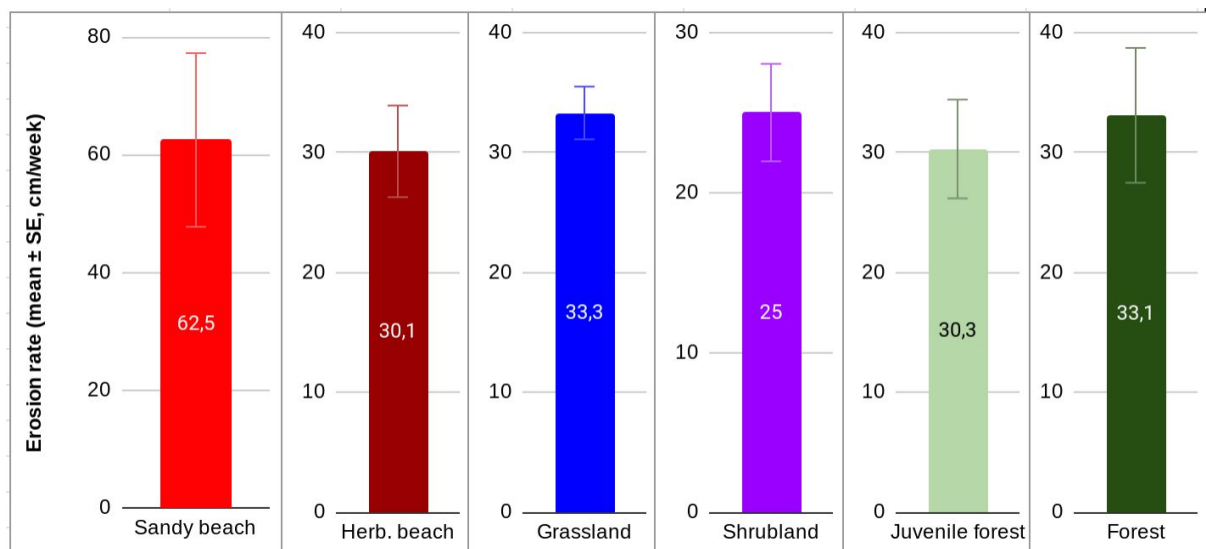
Figure 9: The mean erosion rates for all vegetation types in cm per week, displayed in the centers. The error bars display the found standard errors.

The ANOVA shows an F-statistic value (F-stat) of 0,68. A standard of 0,05 is chosen. Therefore, it can be concluded that there are no differences found in weekly erosion rate between the vegetation types. To support these findings, Table 5 shows all the found results.
