# - BACHELOR THESIS -

## Assessment of the impact of wildfires on the hydrological processes based on different plot scales

A case study of the Serra de Cima catchment in North Central Portugal

Sil van den Groenendal

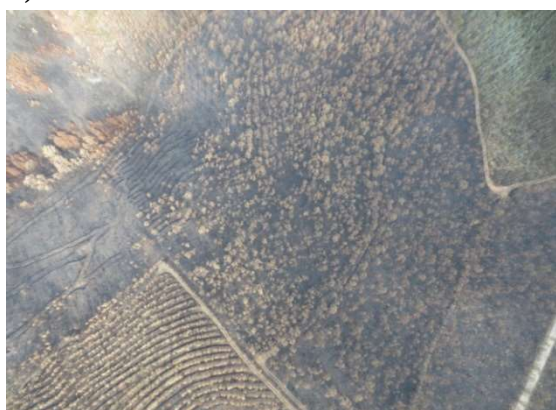
*Figure 2.3 - Post-fire drone picture of the Casa do Padre study site with terraces on the slope*

Terracing is being used when planting eucalypt trees, to make the sites more accessible. Figure 2.3 shows an aerial picture of the SDC site, with eucalypt trees planted onto the terraces (Stoof et al., 2012).

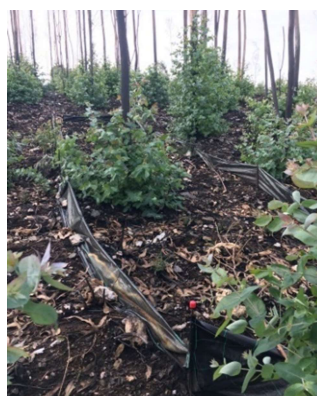
*Figure 2.4 - Slope plot with ploughing, picture taken during fieldwork in Casa do Padre*

The forestry operation ploughing is used in cultivation for soil preparation, where the top soil is being ploughed to bring up nutrients (Figure 2.4). In wildfire affected areas, ploughing (also referred to as rip-ploughing) is done prior to planting eucalypt seeds and timber felling (Ferreira et al., 1997).

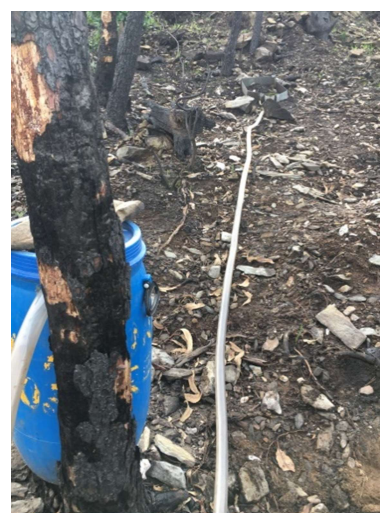
Figure 2.6 - Micro-plot with corresponding storage tank, picture taken during fieldwork in Casa do Padre

Soil losses are being determined from the micro-plots and slope plots using either subsamples (1.5 L water samples) from the runoff tanks, or by measuring and subsampling the sediment and organic matter collected in the sediment fence (Prats et al., 2016).

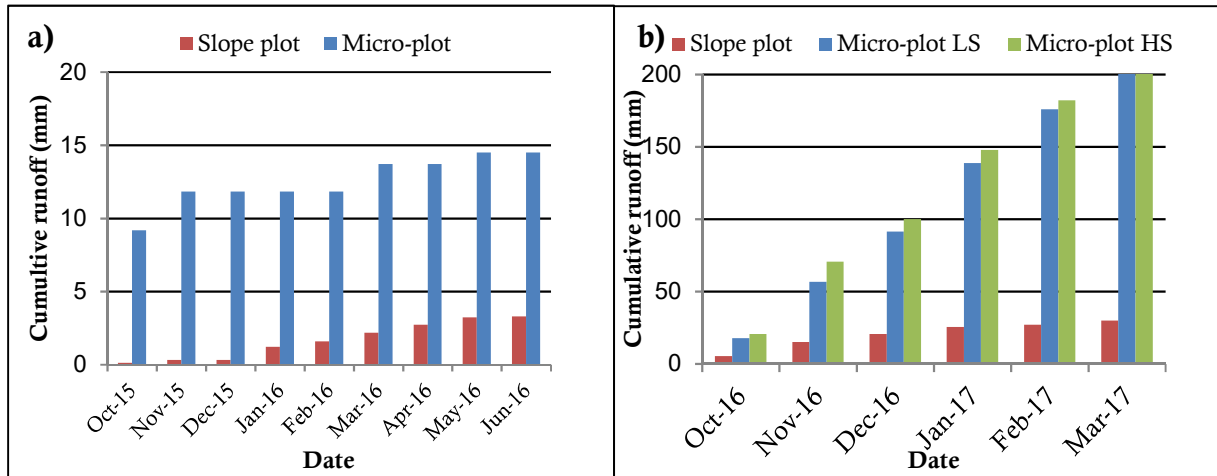
Figure 3.1 - Cumulative runoff pre-fire (a) and post-fire (b). NOTE: y-axes have different scales

The research's data match with what was found in literature by Prats et al. (2015) who found that the upscaling effect leads to a decrease in the overall runoff. He found a total runoff of 956 mm at the micro-plot scale and 58 mm at the slope plot scale during the first year post-fire, which means

that the micro-plots generate 16 times more runoff than the slope plots. This differs from the results in this research, where the micro-plots have 7 times more runoff. This could be caused by the larger amount of rainfall in the research of Prats et al. (2015) or the longer measurement period.

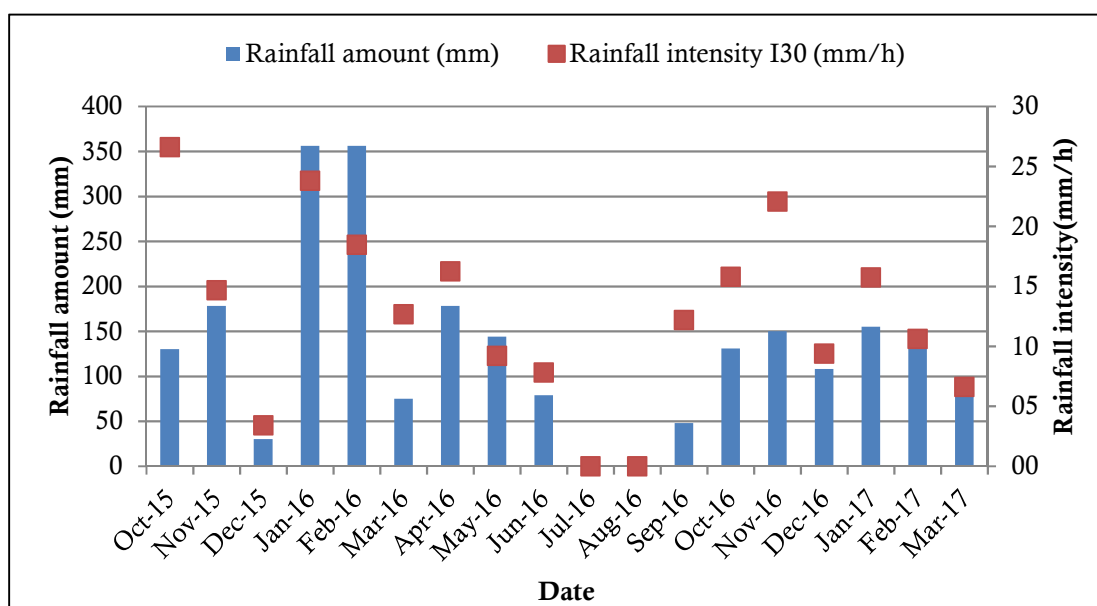
Figure 3.4 - Monthly rainfall amount and monthly maximum 30-min rainfall intensity ( $I_{30}$ )

As seen in Figure 3.4, the precipitation amount in the period preceding the wildfire (which is from 07-10-2015 till 30-06-2016) is much higher than the post-fire period. It must be noted that the 2015 winter was wetter than the one of 2016, and the post-fire data does not include a complete year.

Although the precipitation amount is higher, the 30-min maximum rainfall intensity ( $I_{30}$ ) is uniform for both the pre- and post-fire period (Figure 3.4). The most intense rainfall events are still in the pre-fire period, but the values for the maximum rainfall intensity does not significantly differ.

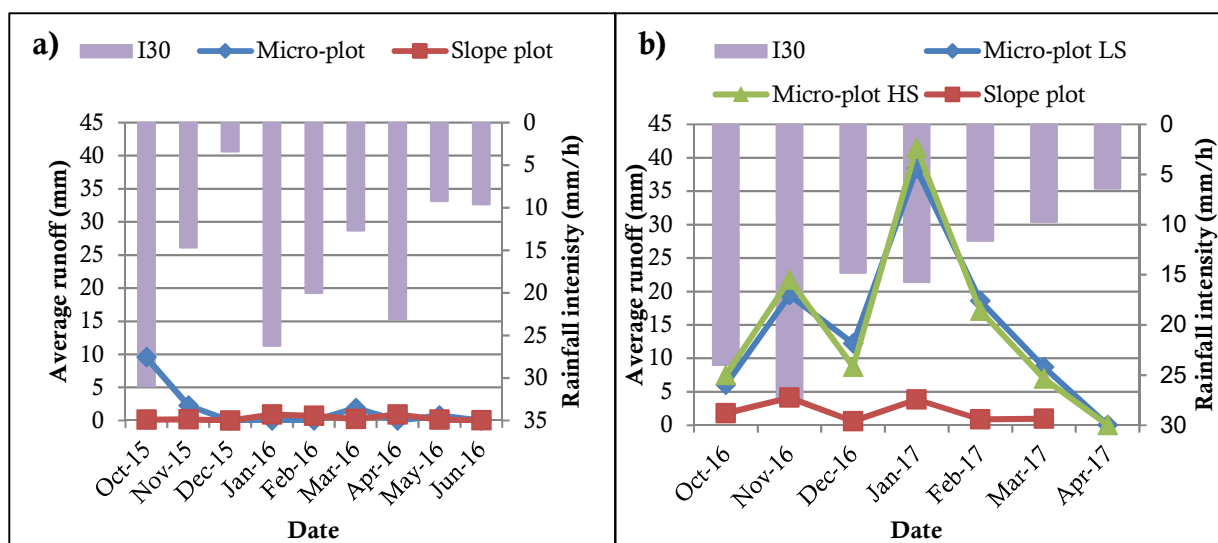
Figure 3.5 - Average runoff and maximum rainfall intensity ( $I_{30}$ ) in pre-fire (a) and post-fire (b) period

The graph (a) shows that where the runoff in the pre-fire period does not respond to higher rainfall intensities during wetter periods, the runoff in the post-fire period increases much more rapid when the maximum rainfall intensities are higher (b).

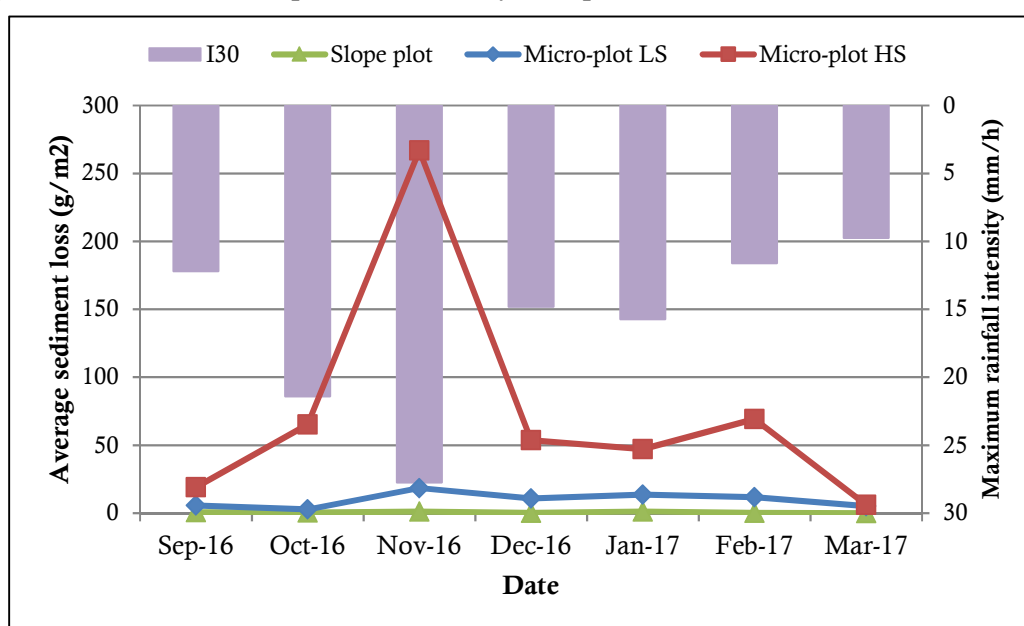
Figure 3.6 - Average monthly sediment losses with the 30-min maximum rainfall intensity ( $I_{30}$ )

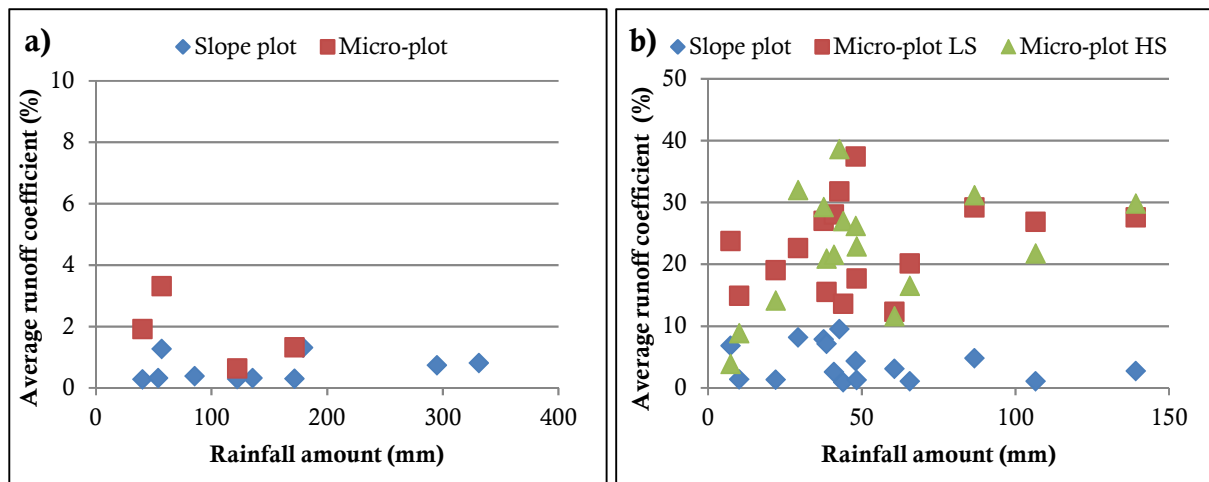
Figure 3.8 - Rainfall vs. runoff coefficient for pre-fire (a) and post-fire (b) period. NOTE: y-axes have different scales

As can be seen in Figure 3.8, there is a change in relationship between the rainfall and the runoff coefficient when comparing the pre-fire period to the post-fire period. For the micro-plots, there is no clear relationship between the rainfall and the runoff coefficient in the pre-fire period. This changes after the wildfire, where the runoff coefficient responds to higher amounts of rainfall. Where the runoff coefficient in the pre-fire period does not exceed 10%, the post-fire micro-plots show 30 to 40 percent of runoff coefficient during increased rainfall amounts. Still, the correlation between the rainfall and the runoff coefficient does not increase significantly. Only the high severity micro-plots show a bigger correlation, but this is still not a strong relationship.

The slope plots in the post-fire period show no change of relationship. Although the post-fire slope plots have a response of a higher runoff coefficient during rainfall, the relationship between the amount of rainfall and the average runoff coefficient in both the pre- and post-fire period is not evident for the plots.

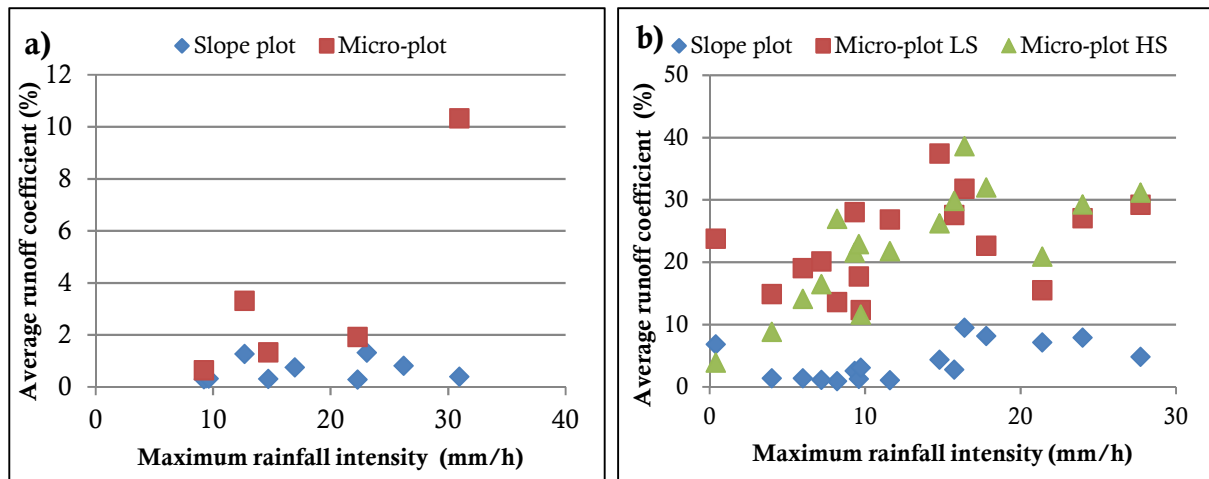
Figure 3.9 -  $I_{30}$  vs. runoff coefficient for pre-fire (a) and post-fire (b) period. NOTE: y-axes have different scales

Regarding the 30-min maximum rainfall intensity ( $I_{30}$ ), the graphs in Figure 3.8 show that the relationship with the runoff coefficient changes during the research period. For the micro-plots, Figure 3.9 and Table 3.3 show that for the micro-plots the correlation between the rainfall and runoff coefficient has become less in the post-fire period, changing from 0.70 to 0.16 (low severity) and 0.56 (high severity).

For the slope plots in the pre-fire period, there is also a change of relationship visible. The post-fire slope plots show a much larger response to the rainfall intensity, a relationship which was not present in the results of the slope plots in the pre-fire period.

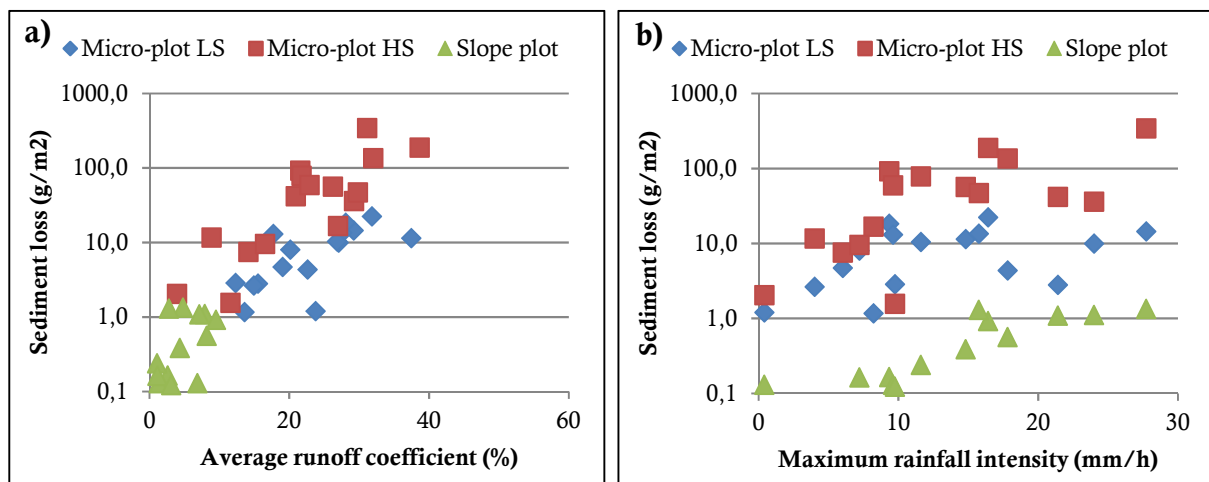
Figure 3.10 - Post-fire sediment losses vs. runoff coefficient (a) and  $I_{30}$  (b). NOTE: y-axes have a logarithmic scale

Figure 3.10a shows that the relationship between sediment loss and the runoff coefficient is only clearly visible in each of the research plots, with the low severity micro-plots having the strongest correlation (with a  $R^2$  of 0.51).

A different pattern appears when looking at the relationship with the 30-min maximum rainfall intensity. Here it shows that the relationship with the sediment losses are the most evident in the slope plots. The low severity micro-plots show a weaker relationship with the 30-min maximum rainfall intensity, as opposed to the strong relationship with the runoff coefficient.

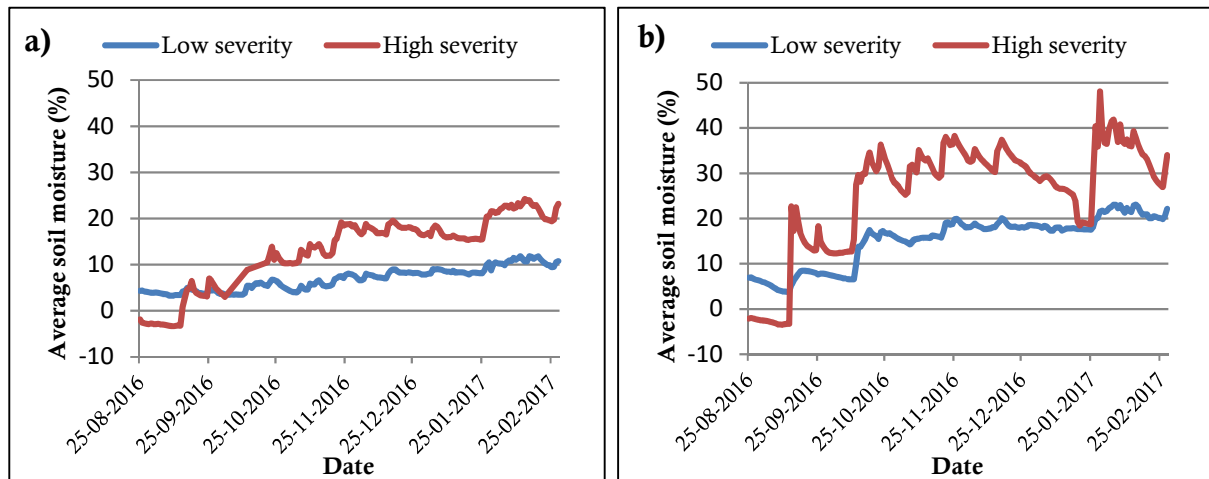
Figure 3.13 - Average soil moisture content for 2.5 cm depth (a) and 7.5 cm depth (b)

The data shows that the average soil moisture is higher in the high severity area, and that the soil moisture has a higher average value deeper in the top soil layer.
