# Final thesis report

## Galgeplaat tidal flat and its future

INVESTIGATION ON THE MORPHODYNAMICS OF THE GALGEPLAAT AND A FIRST  
EXPLORATION TO A SAND NOURISHMENT ON THE GALGEPLAAT TIDAL FLAT

*Civil Engineering – HZ University of Applied Sciences*

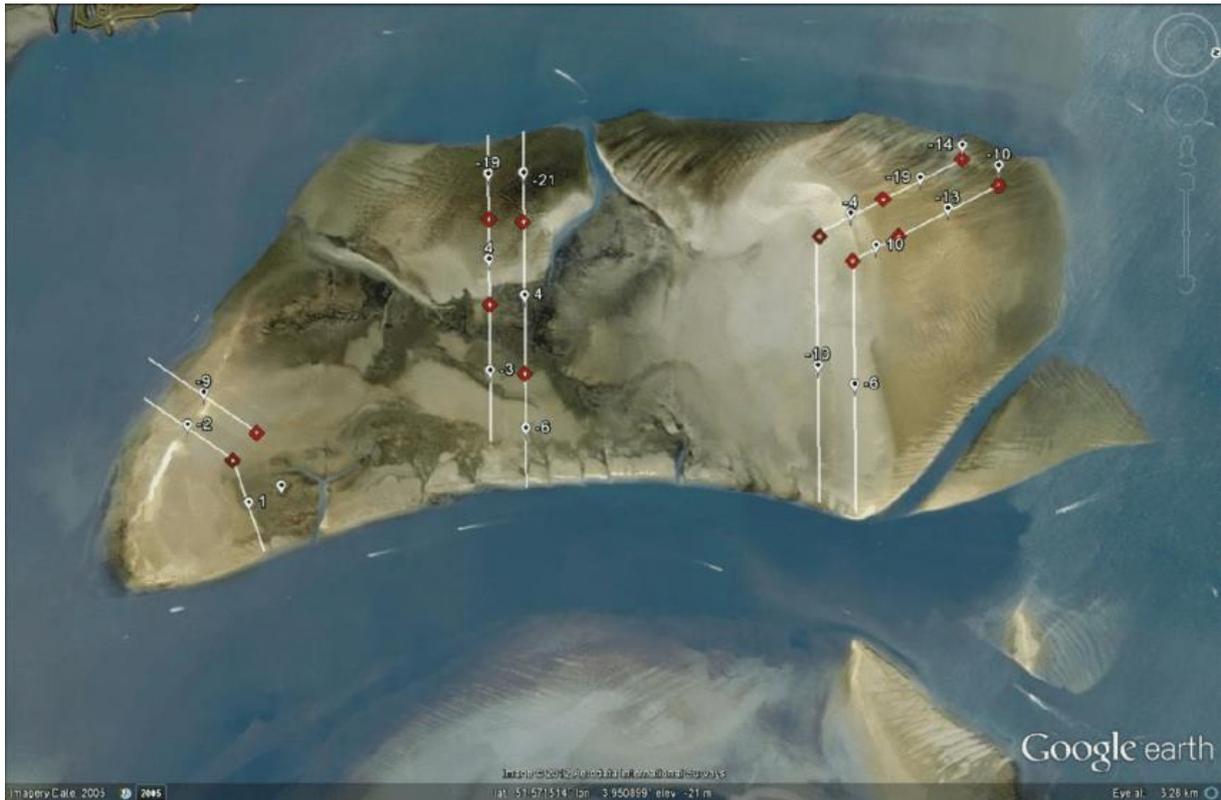
Figure 1.3.1 Values shown are the coefficients of the linear trend of average heights [mm/year] (Deltares, 2012)

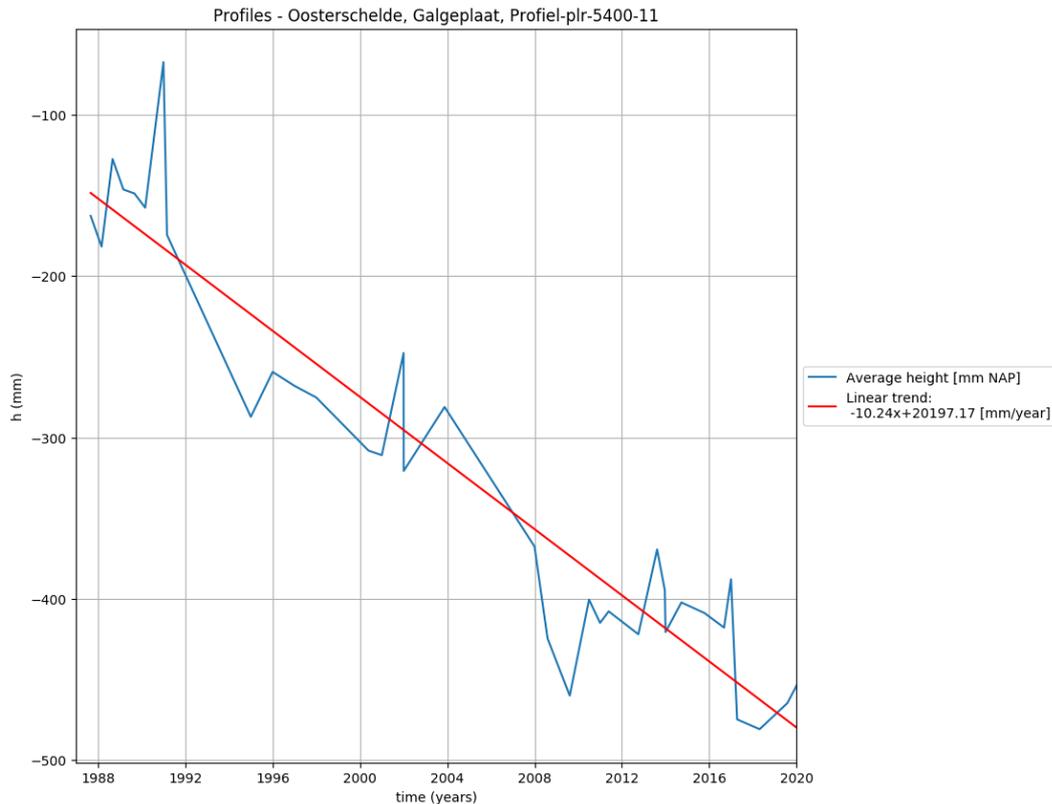
Figure 4.3.8 Profile 5400 compared with the height trend (Rijkswaterstaat) without breakpoint

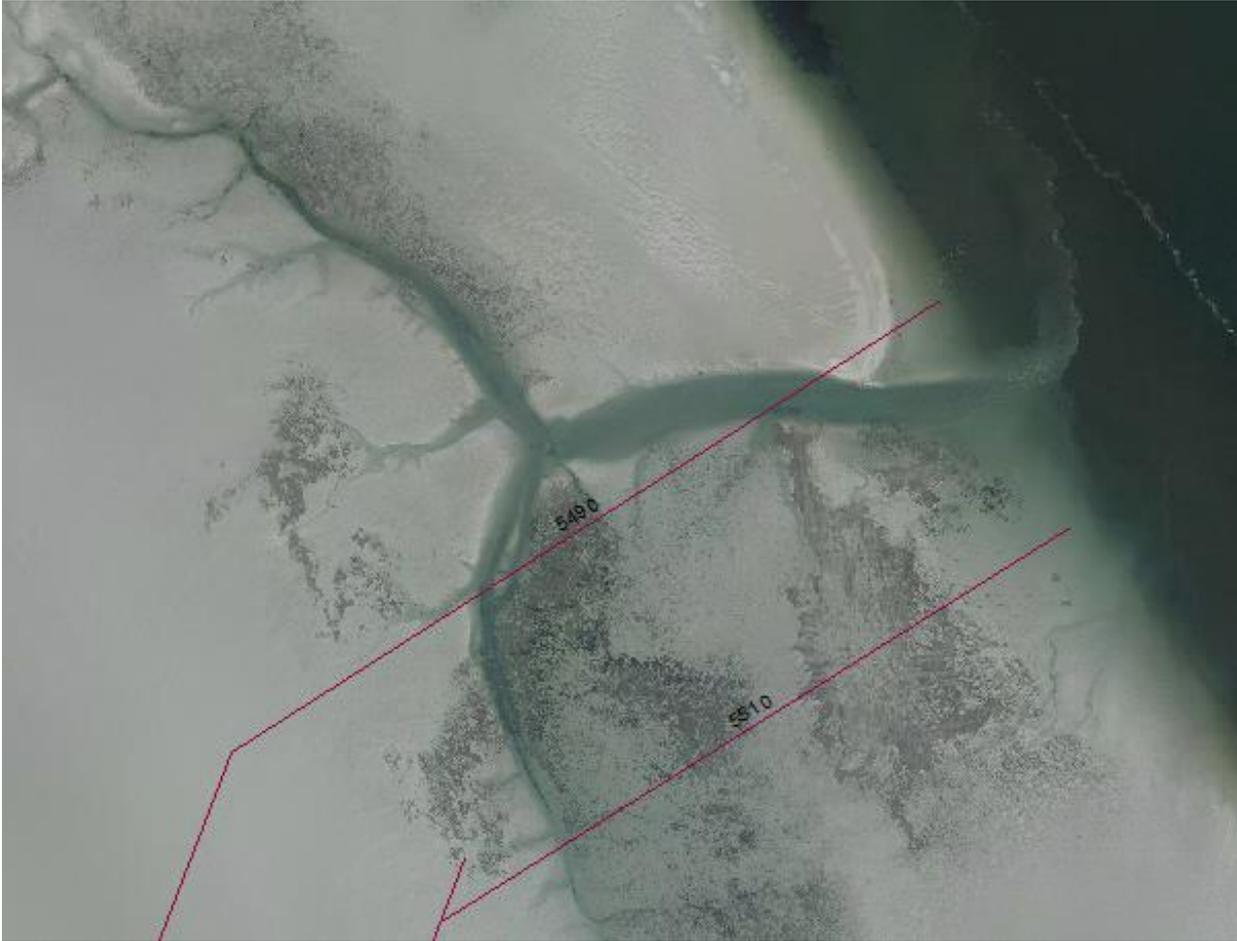
Figure 4.3.11 The line of profile 5490 plotted in the satellite photo of 2011 (Rijkswaterstaat)

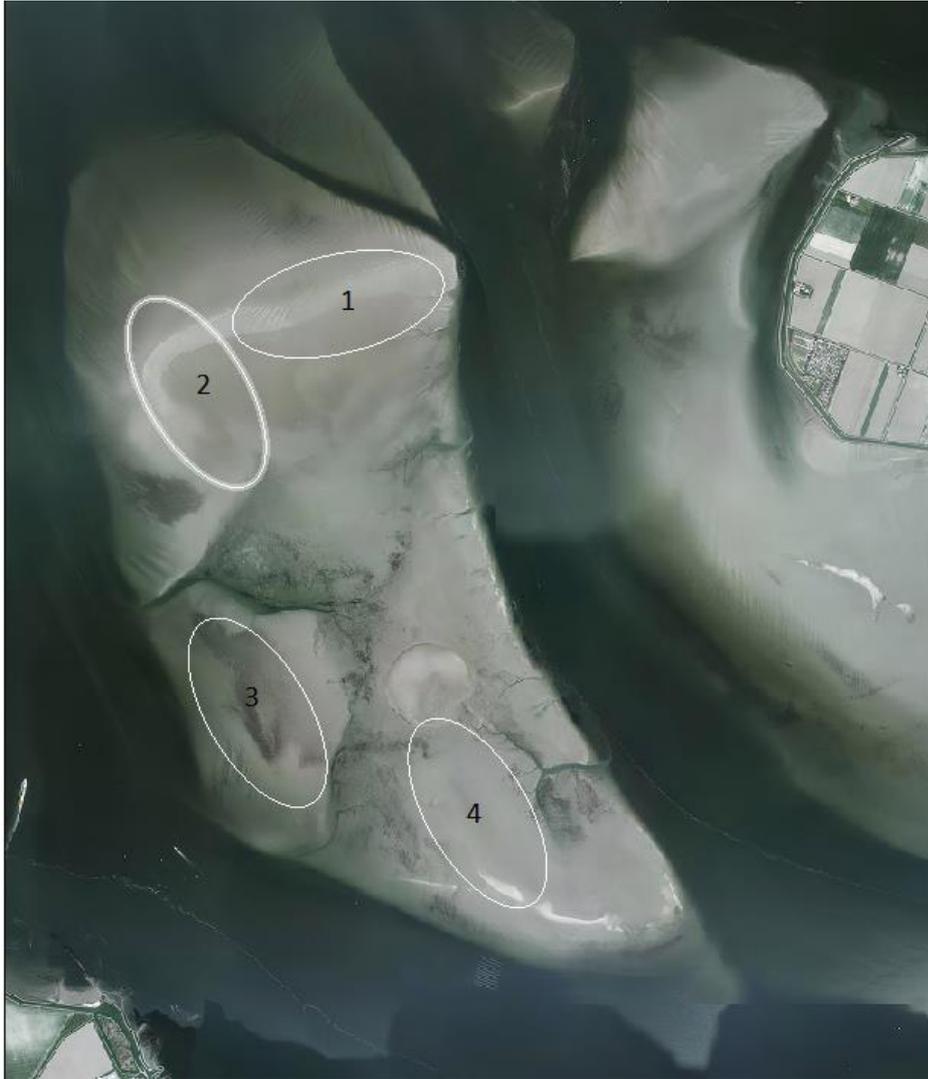
Figure 4.7.1 The proposed locations for the nourishment

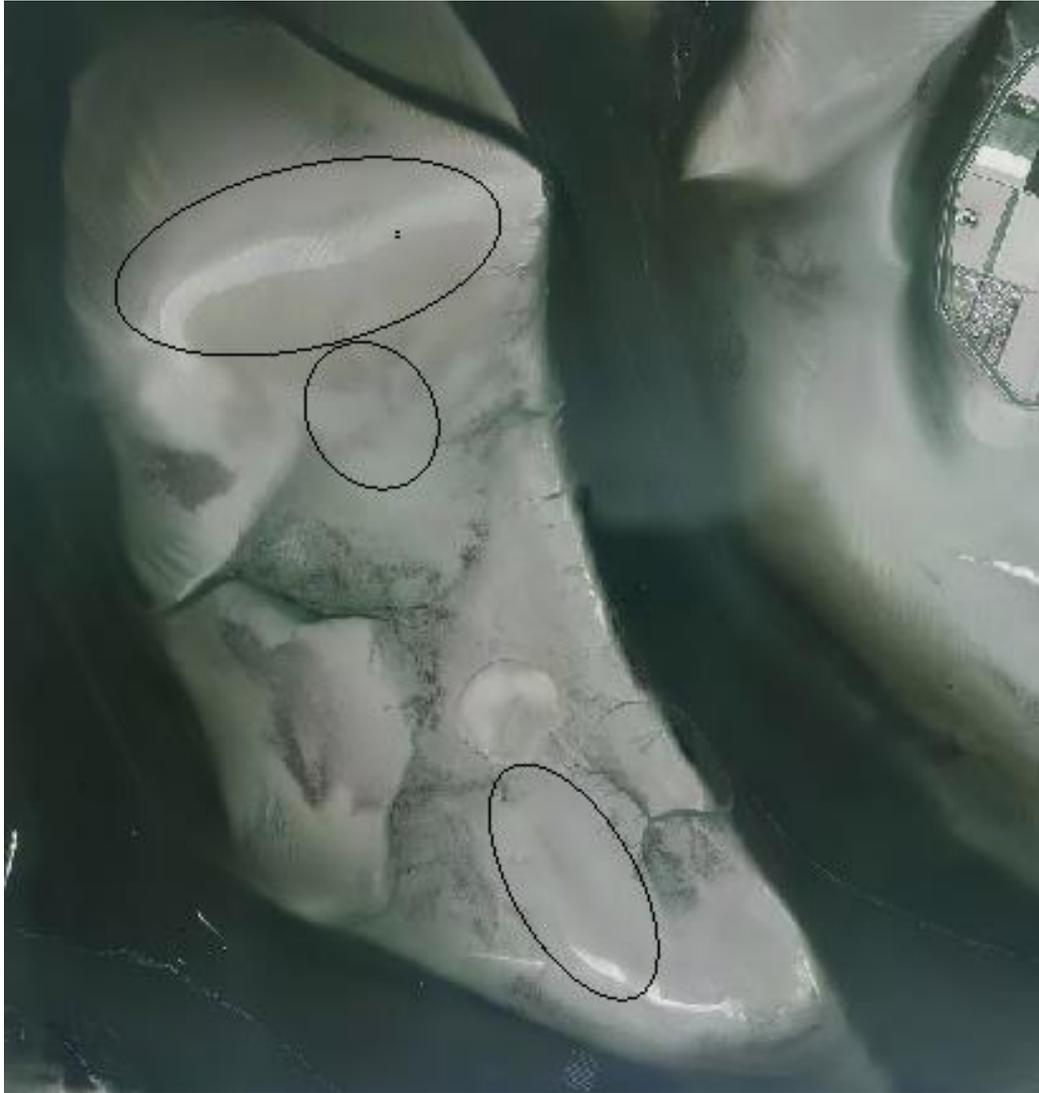
*Figure 4.7.2 New variants based on the MCA*

From the MCA is concluded that the northern part of the Galgeplaat tidal flat is a suitable location for nourishment. Since option three has scored the lowest this area is considered to be less suitable. The fourth option, which is close to the pilot nourishment, is still a realistic location for the nourishment. Therefore, different suitable locations have been further modified to obtain the best recommendations for the deposit areas of the nourishment.
