# Overflow tests on Dutch levees

Adaptation  
to climate  
change

## Overflow tests on Dutch levees

1.0 – 20221222

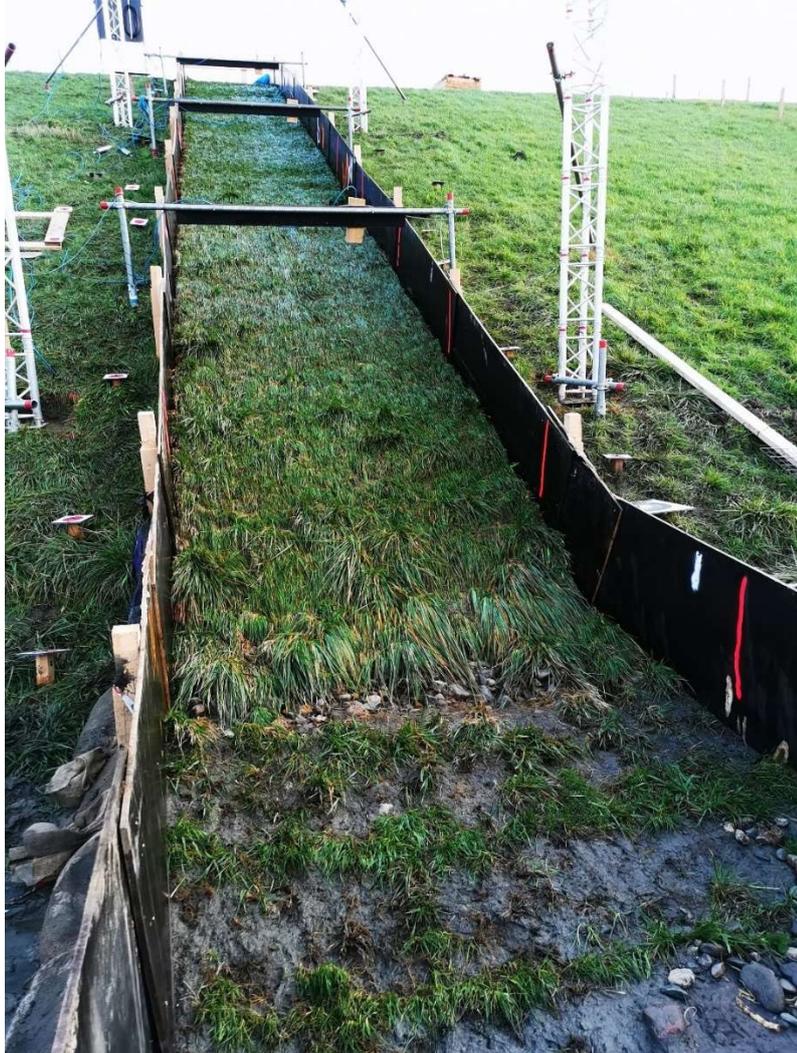
The test section is 2 m wide, sided by wooden boarding, and the surface is considered to be in a good condition without any visible anomalies (such as burrows, objects or other damage) on the slope. At the toe, there are some crane track marks (visible in Figure 6), but its influence on the overflow process – especially on the slope – was deemed negligible.

Figure 6 - View on test section N-OF01 (25/11/2020 08:41).

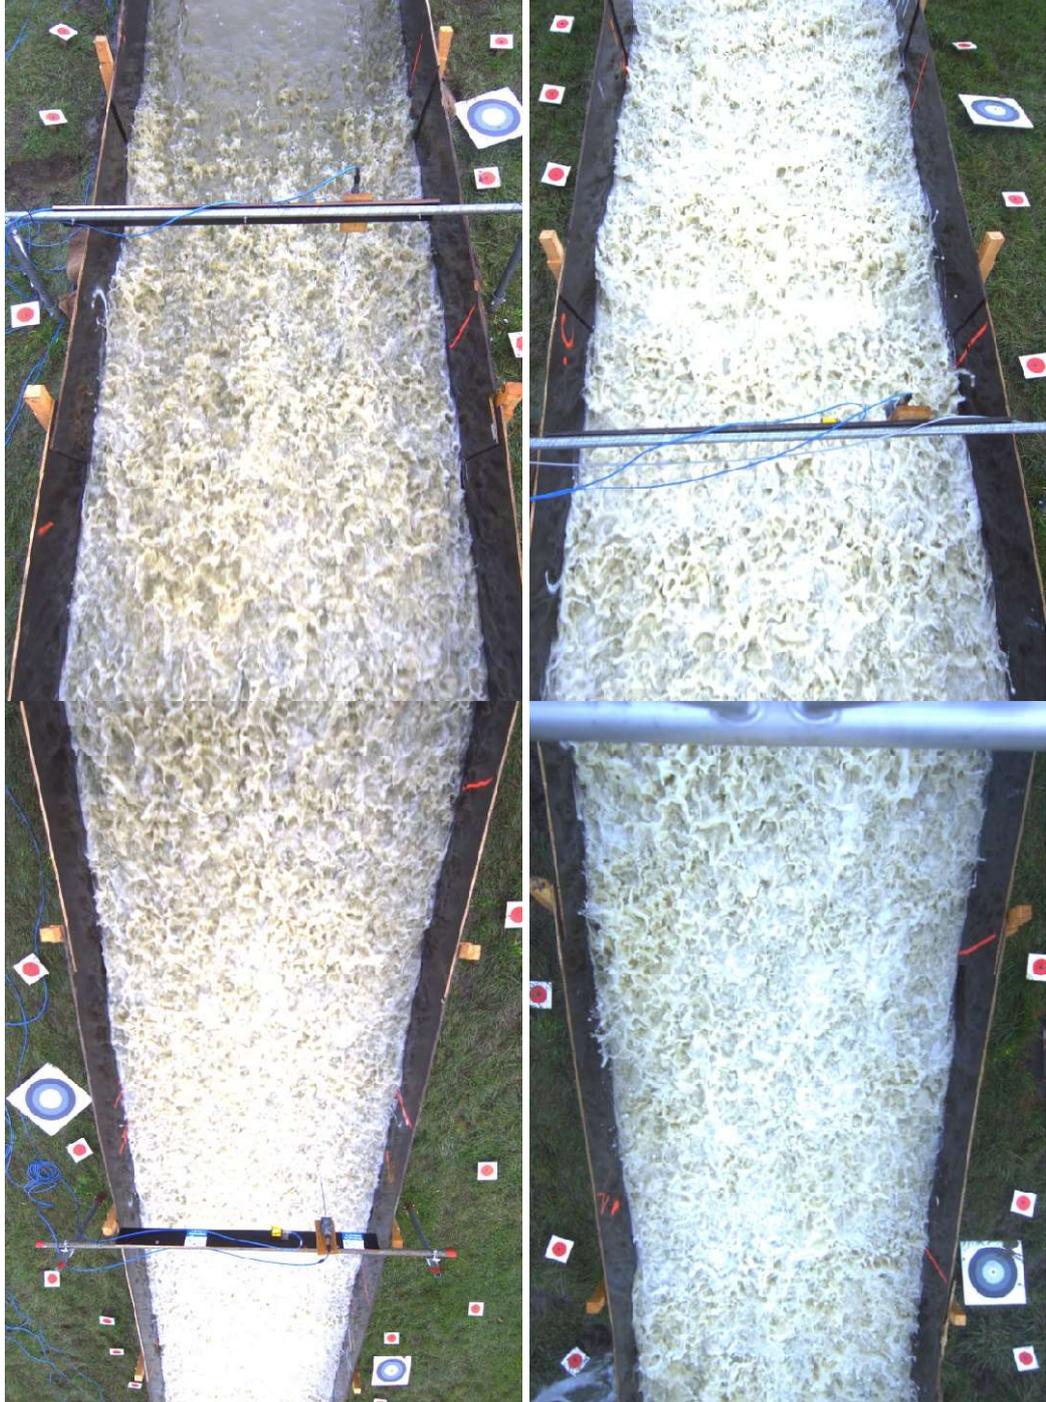
B15 flow surface (26/11/2020) ^ CREST

Figure 9 – Images during overflow section N-OF01 block B15. (left upper portal , right lower portal)

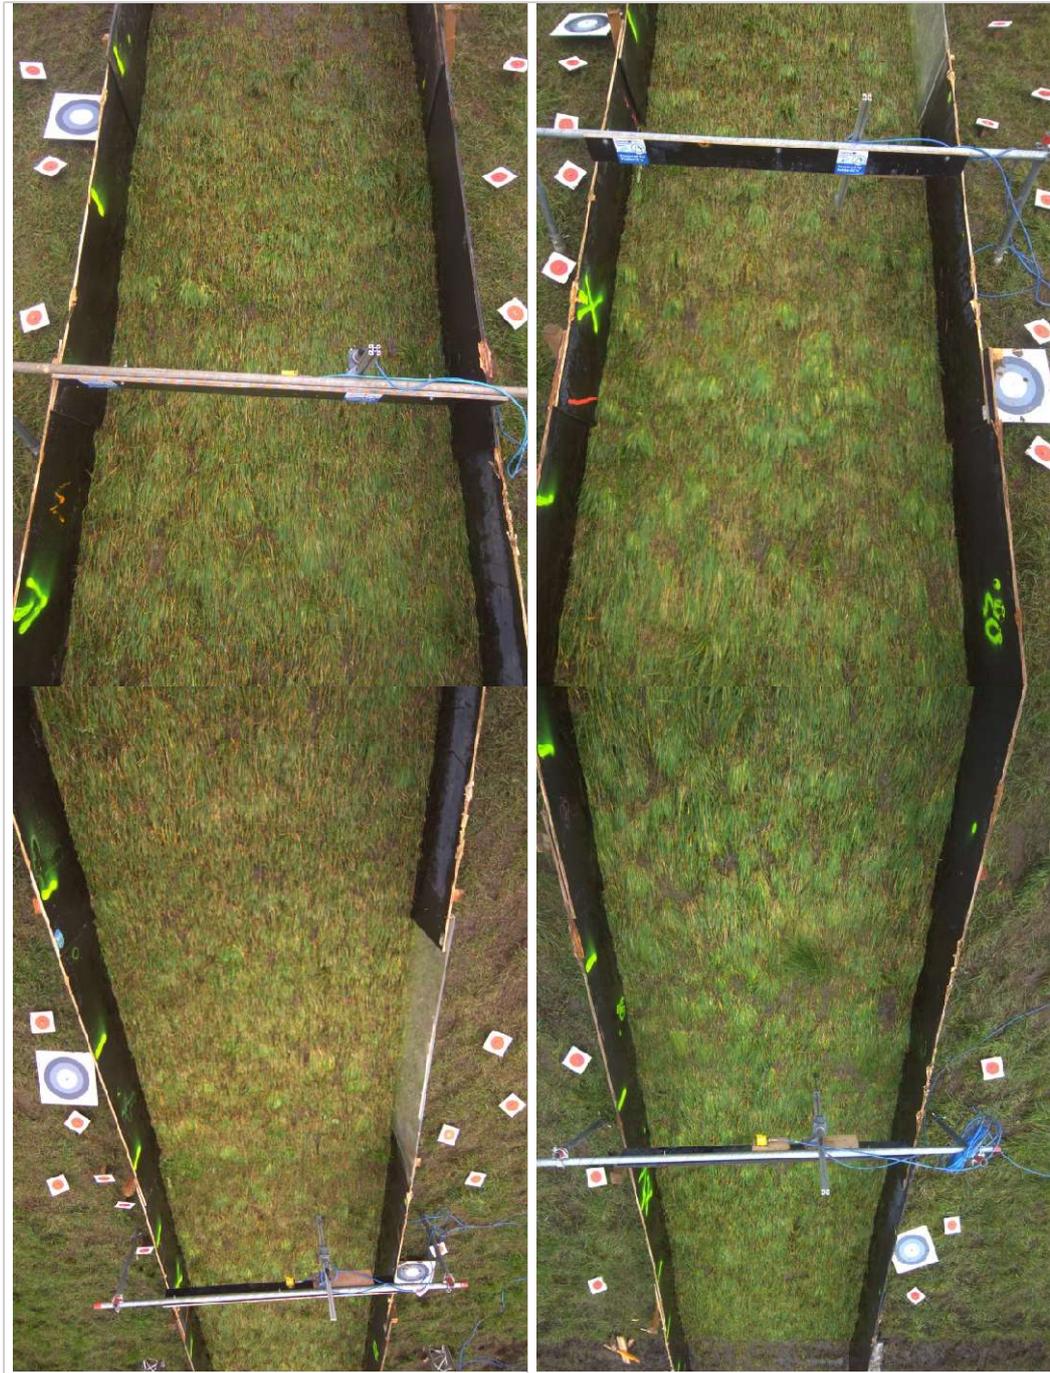
Figure 15 – Levee state in block B01. Left are camera 1 and 2. Right are camera 3 and 4. levee crest is in the upward direction, levee toe is in the downward direction.

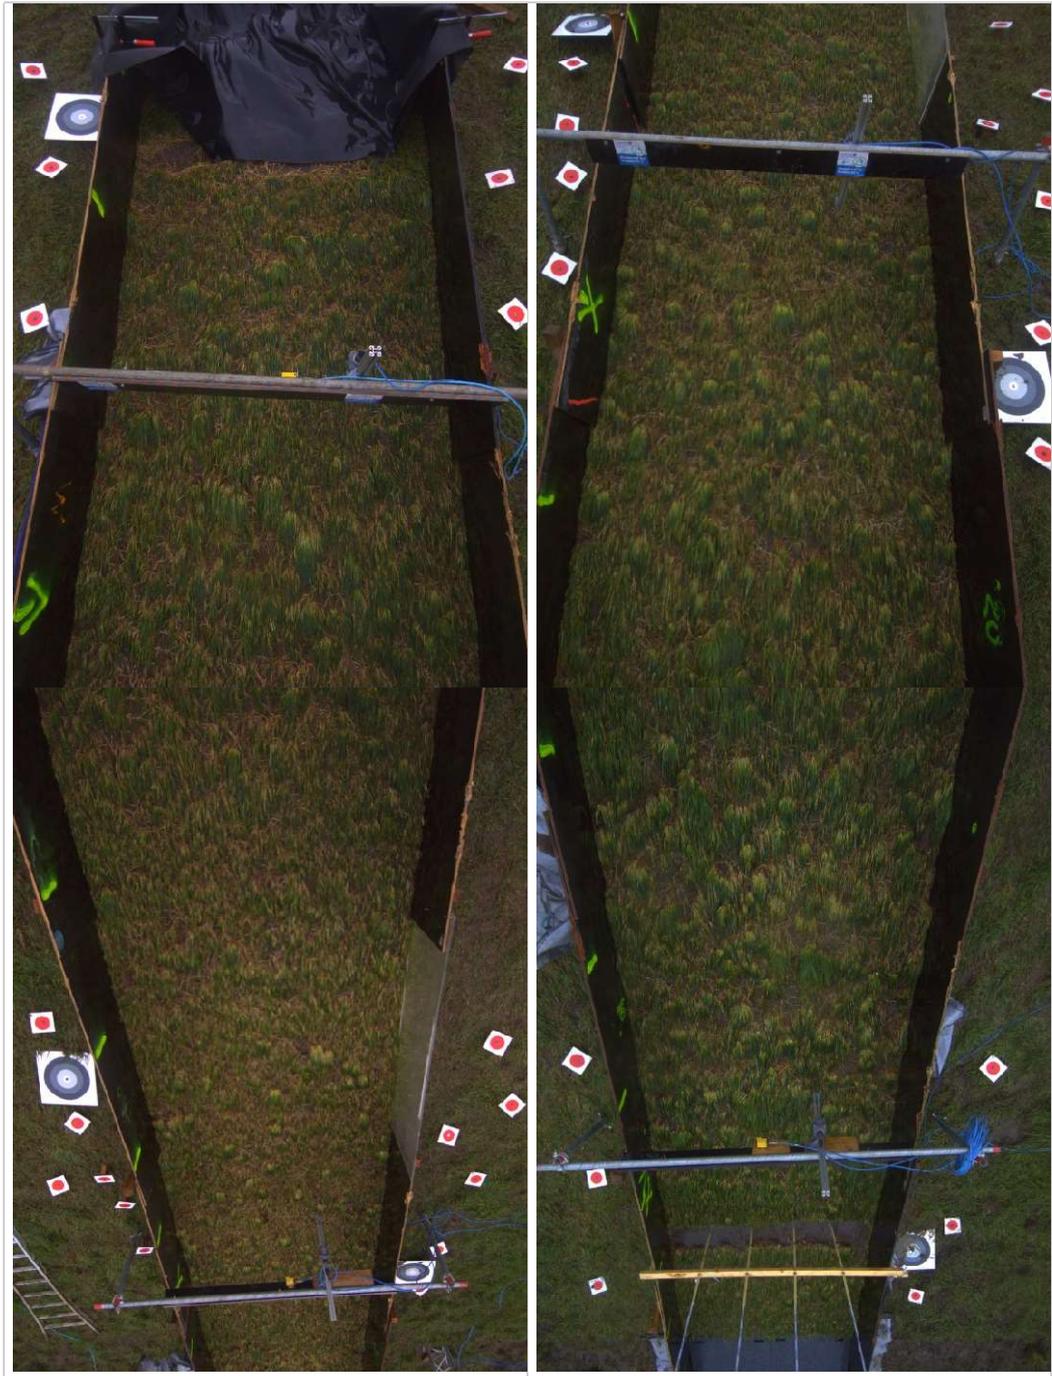
Figure 16 – Levee state in block B10. Left are camera 1 and 2. Right are camera 3 and 4. levee crest is in the upward direction, levee toe is in the downward direction. The erosion experiment is visible in the image of camera 4.

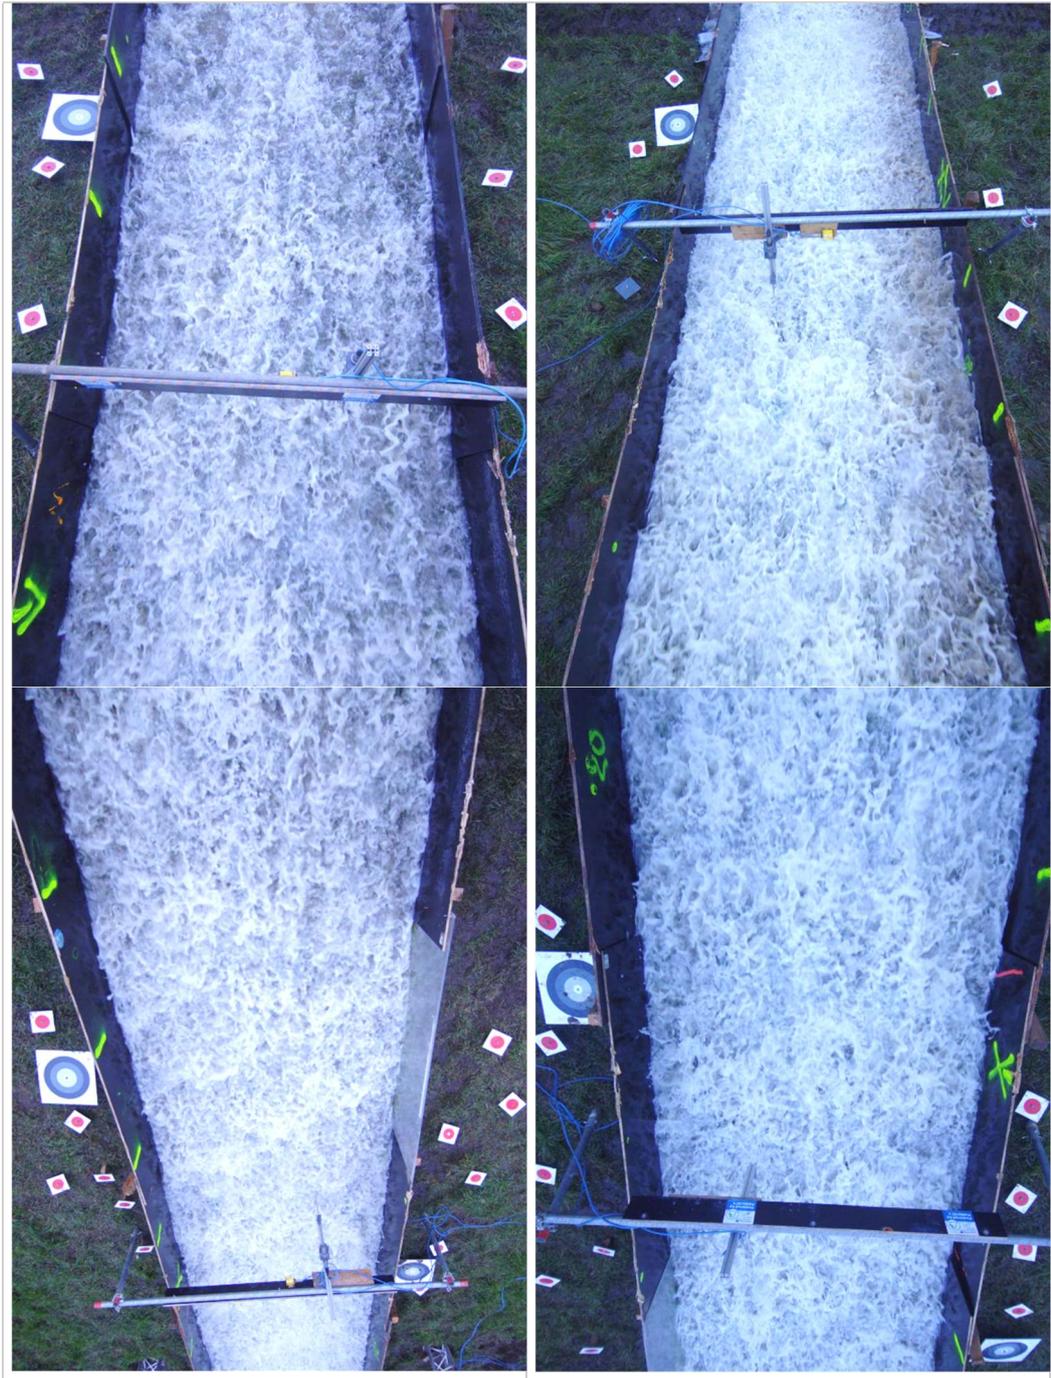
Figure 17 – Levee state during overflow in block B2.

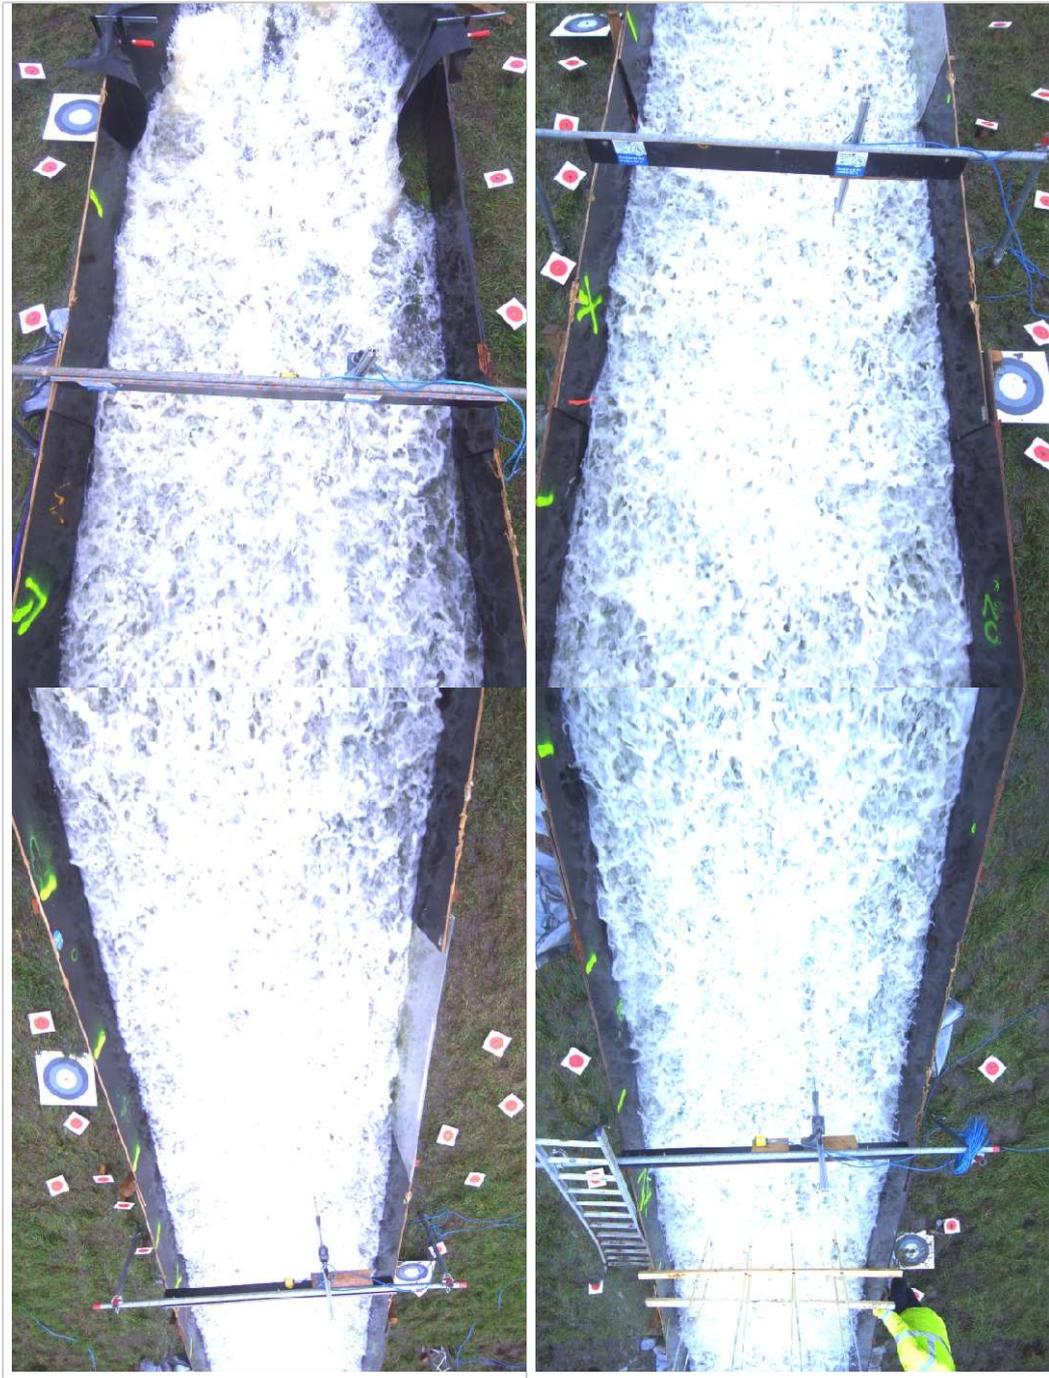
Figure 18 – Levee state during overflow in block B10 (discharge  $165 \text{ l.s}^{-1}.\text{m}^{-1}$ ).

The evolution of the vegetated levee under normal overflow conditions corresponds to the observations for the reference section N-OF01, albeit for a shorter time span: 8 hours after 2 days of testing lead to no significant damage to the levee.

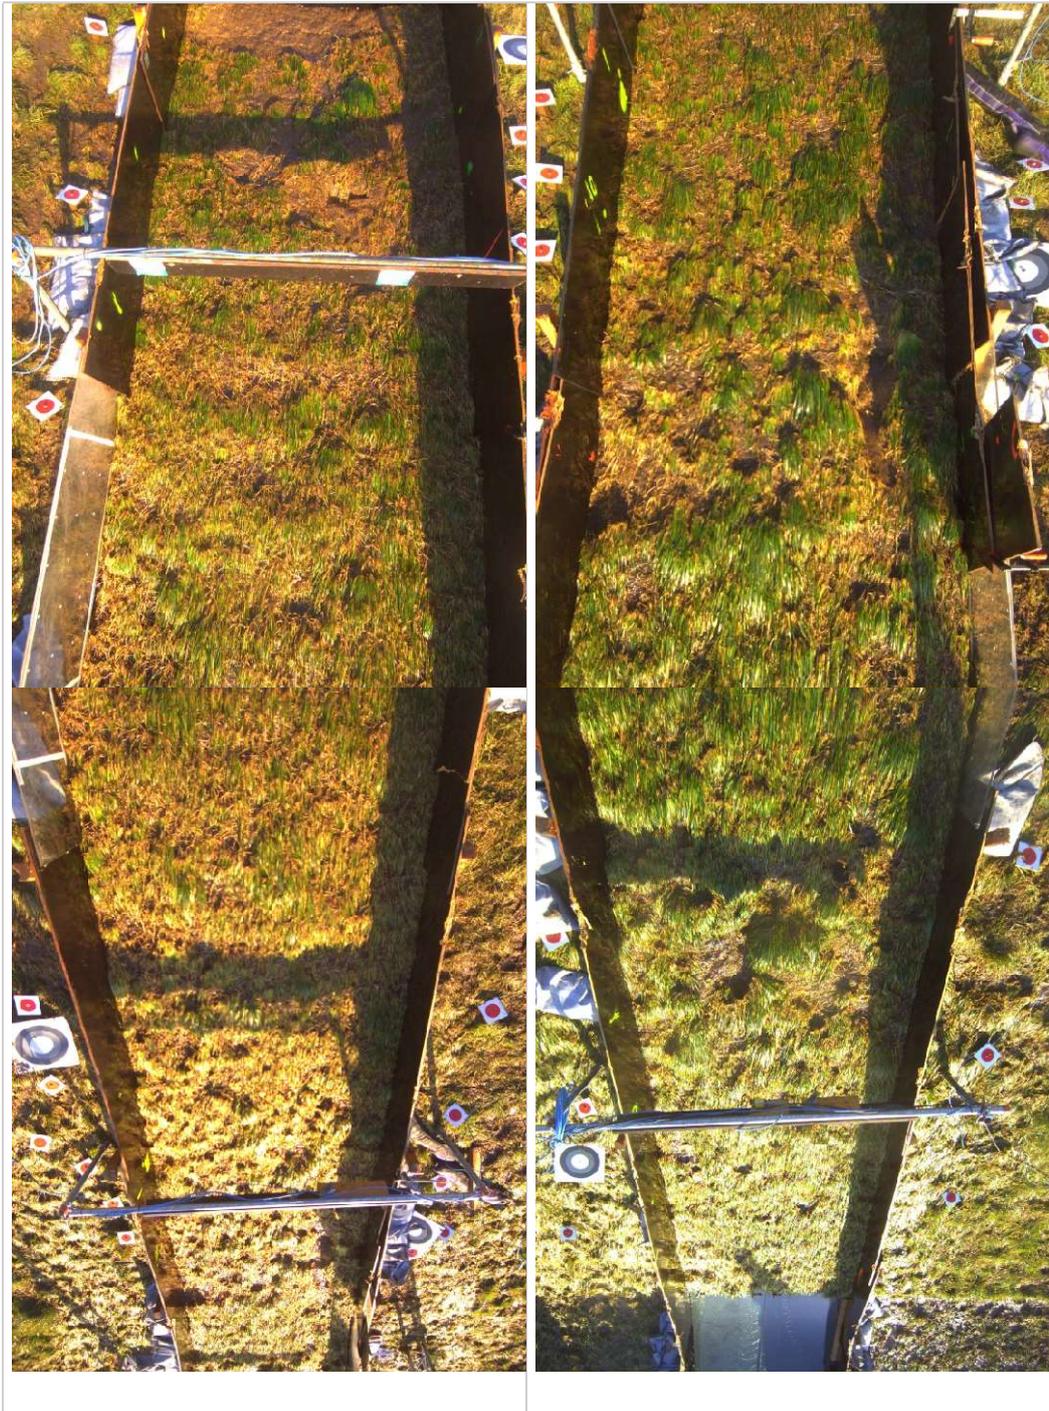
During the course of the experiment however, it is seen that the normal evolution as in other reference tests is ongoing: slight soil erosion and increasing exposure of vegetation root systems. However, there is no critical damage being created and the overall slope is holding.

Figure 25 – Levee state in block B10. Left are camera 1 and 2. Right are camera 3 and 4. levee crest is in the upward direction, levee toe is in the downward direction.

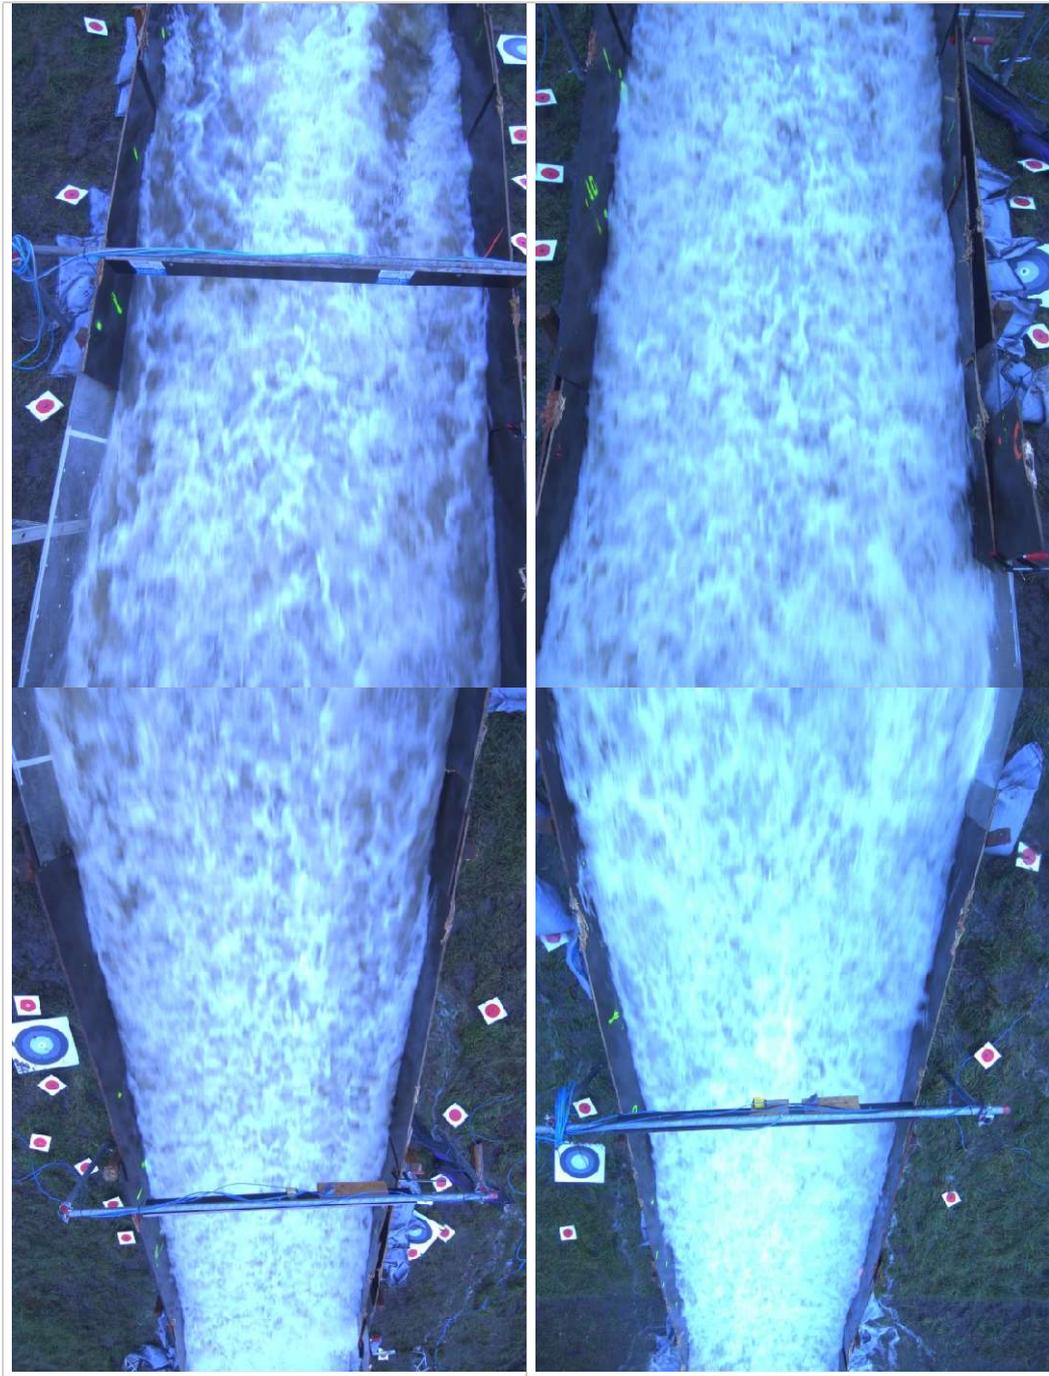
Figure 26 – Levee state during overflow in block B7.

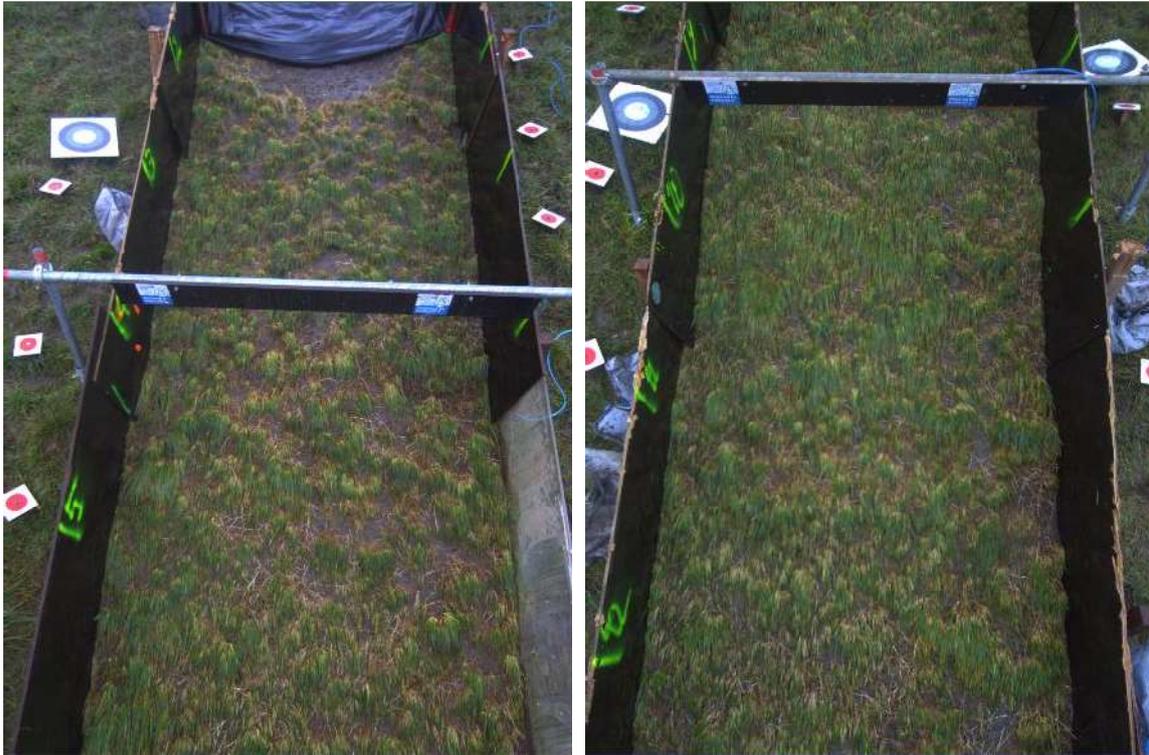
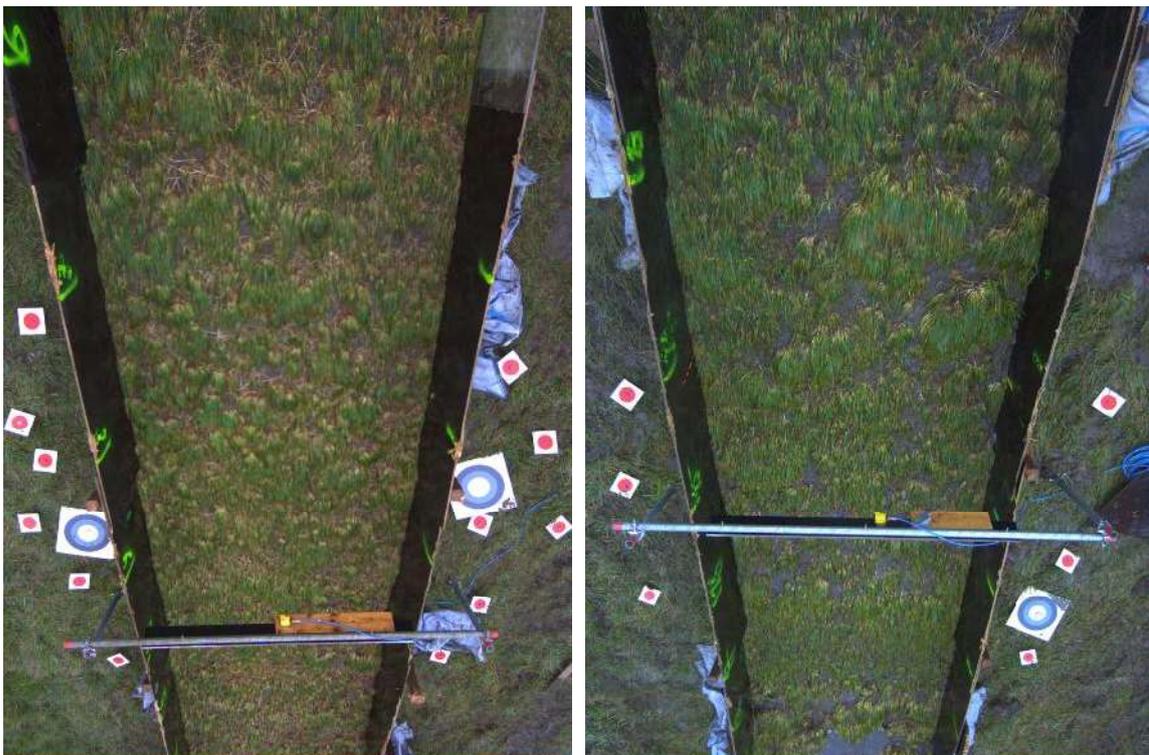
After the test, the most significant damages could be observed at the transition between EPDM and bare soil on the crest (erosion depth 1-2 cm in an area approx. 20 x 80 cm), at the toe (erosion depth 5-10 cm in an area approx. 10 x 80 cm) and at the downstream transition between asphalt and soil (erosion depth 45-50 cm in an area approx. 30 x 30 cm).

Figure 32 - Final surface photography (ID: NL\_OF04\_Q000\_B18\_S\_1429)

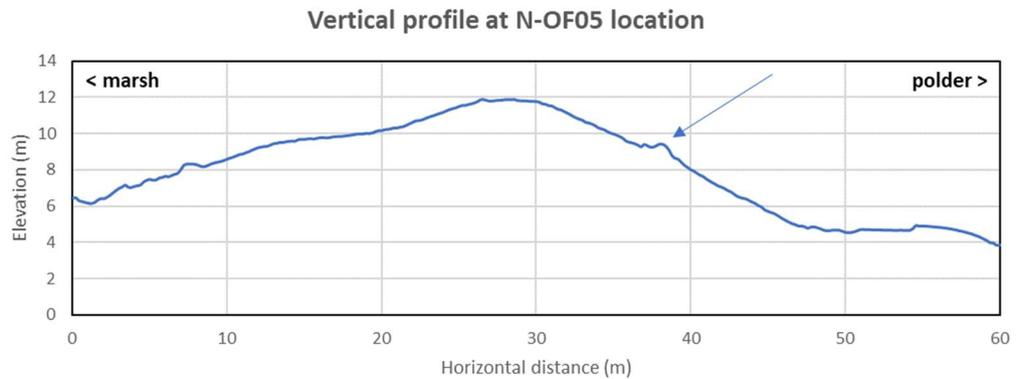
The levee profile is depicted in Figure 35. On the profile, the presence of the burrow is clearly visible, as well as the small sand mound in front of the burrow entrance.

Figure 35 - Topographical profile over the N-OF05 site. Arrow indicates the sand mound in front of the burrow.

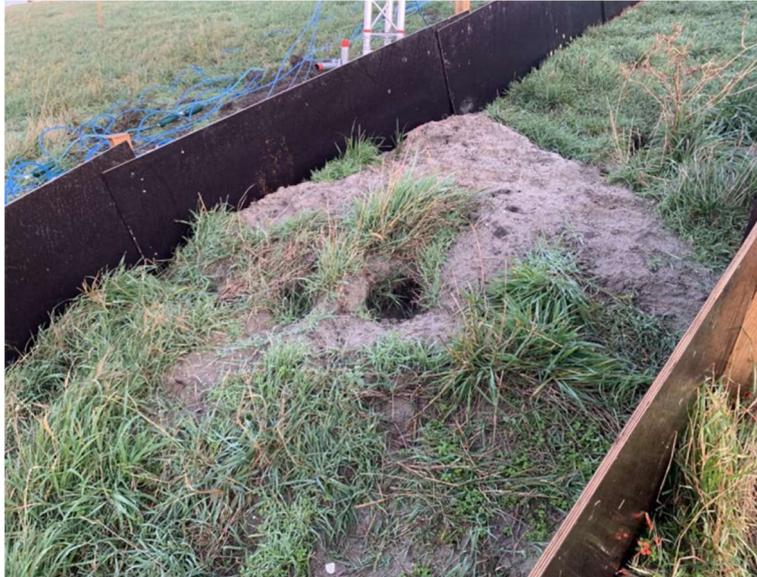
The rabbit burrow on the N-OF05 section is situated in the middle of the section. A mound of sand is located around the burrow (Figure 36). During the first block of the experiment, the sand mound around the rabbit burrow was washed away, coloring the overflowing water, muddy brown (Figure 37). This event exposed a piece of wire fence. From levee watches, it was confirmed that a rabbit hole had existed on this location and had been repaired before (Figure 39). Apparently, this repair included the placement of a wire fence to cover the old burrow (unsuccessfully, apparently).

Figure 36 - Rabbit burrow before the start of the experiment.

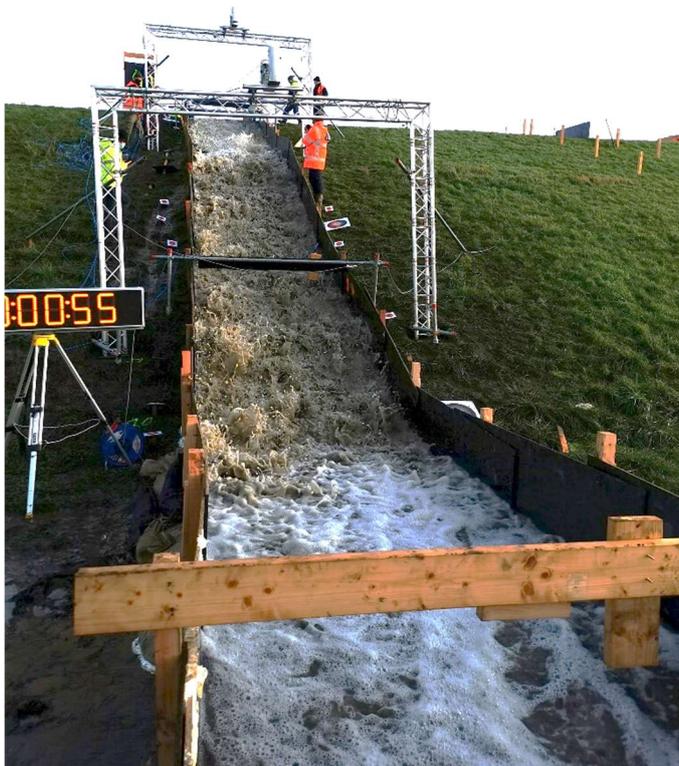
Figure 37 - Initial erosion of the sand mound of the rabbit burrow.

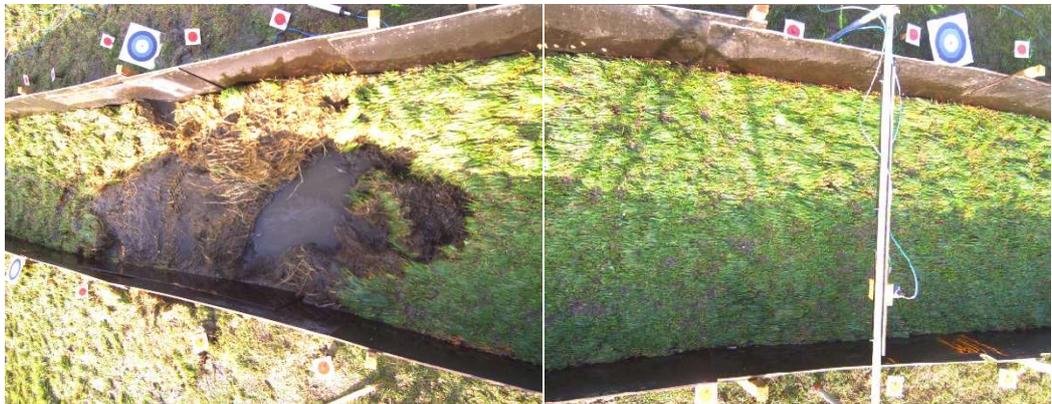
Figure 43 shows the state when the erosion of the burrow area is starting to advance: in front (left) of the burrow entrance, an erosion pit has formed, but the soil is still being stabilized because of the wire fence that is present in the clay layer. The burrow itself is starting to collapse.

Figure 43 - Composed image of the burrow area after the an erosion pit has formed and the burrow starts to collapse (B5).

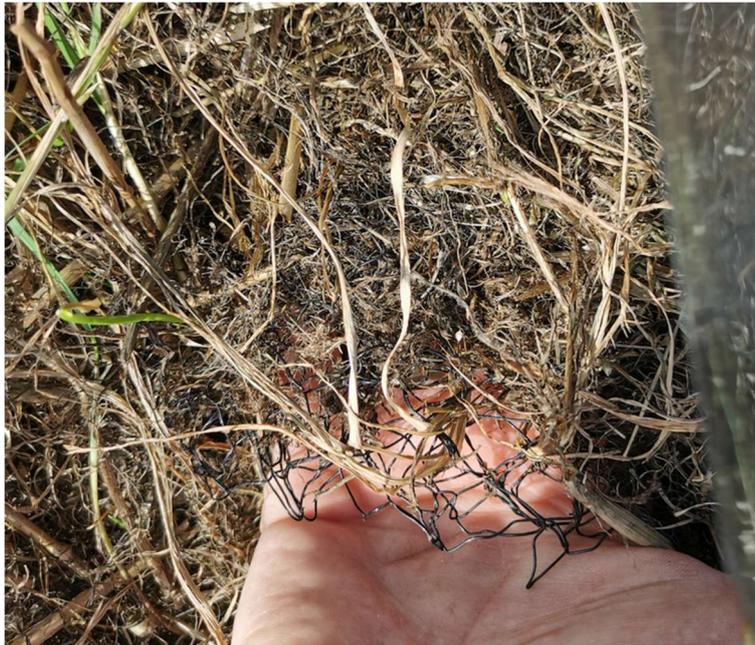
These two subsections were retested, but failed very quickly. Although the vegetation may not have been developed as in a well-maintained grass cover, it was observed that on each section, gullies developed from the top of the levee downward. These gullies appeared to be about 2.5 m apart, the width of the tracks of the cranes that were used during the repair.

The differential compaction of the soil and the infill of the track depression with looser soil gave immediately rise to erosion of the soil in these track depressions, and thus forming gullies. The gullies cut through the cover layer and exposed the sand core. Whilst performing overflow on the 05C section, water flow was observed in the exposed sands of 05B.

Figure 48 - Detail of the RTM solution on section N-OF05C.

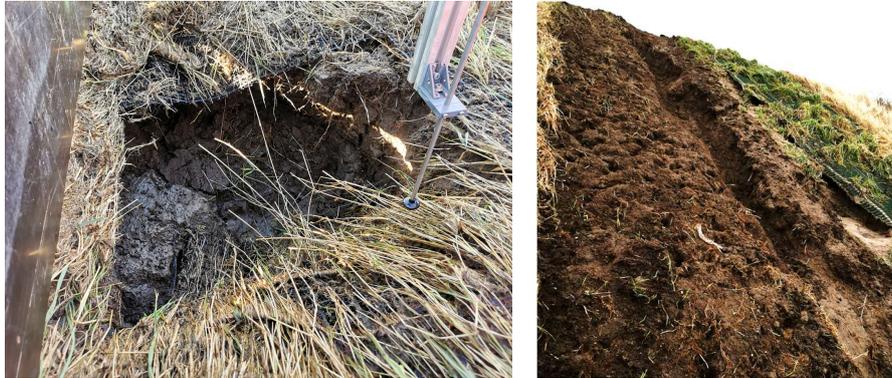
During the experiment, it was observed that water was flowing out along two lines from the top to the bottom of the crest all the way down. These lines were about 40 cm wide and were separated by 2.5 m. It was considered and confirmed afterwards that these lines were actually corresponding to the tracks of the crane that was used during the removal of the grass cover and installation of the RTM solution. In this process, gullies were formed that were filled with (less compacted) soil afterwards. It is thought that this soil was quickly eroded and formed very

Given the artifact created by the crane track, it is considered unreasonable to make any conclusions regarding the RTM solution for slope stabilization and therefore, the test should be considered as a failure.

Figure 51 - View on the gully after partial and complete removal of the RTM solution on section N-OF06.

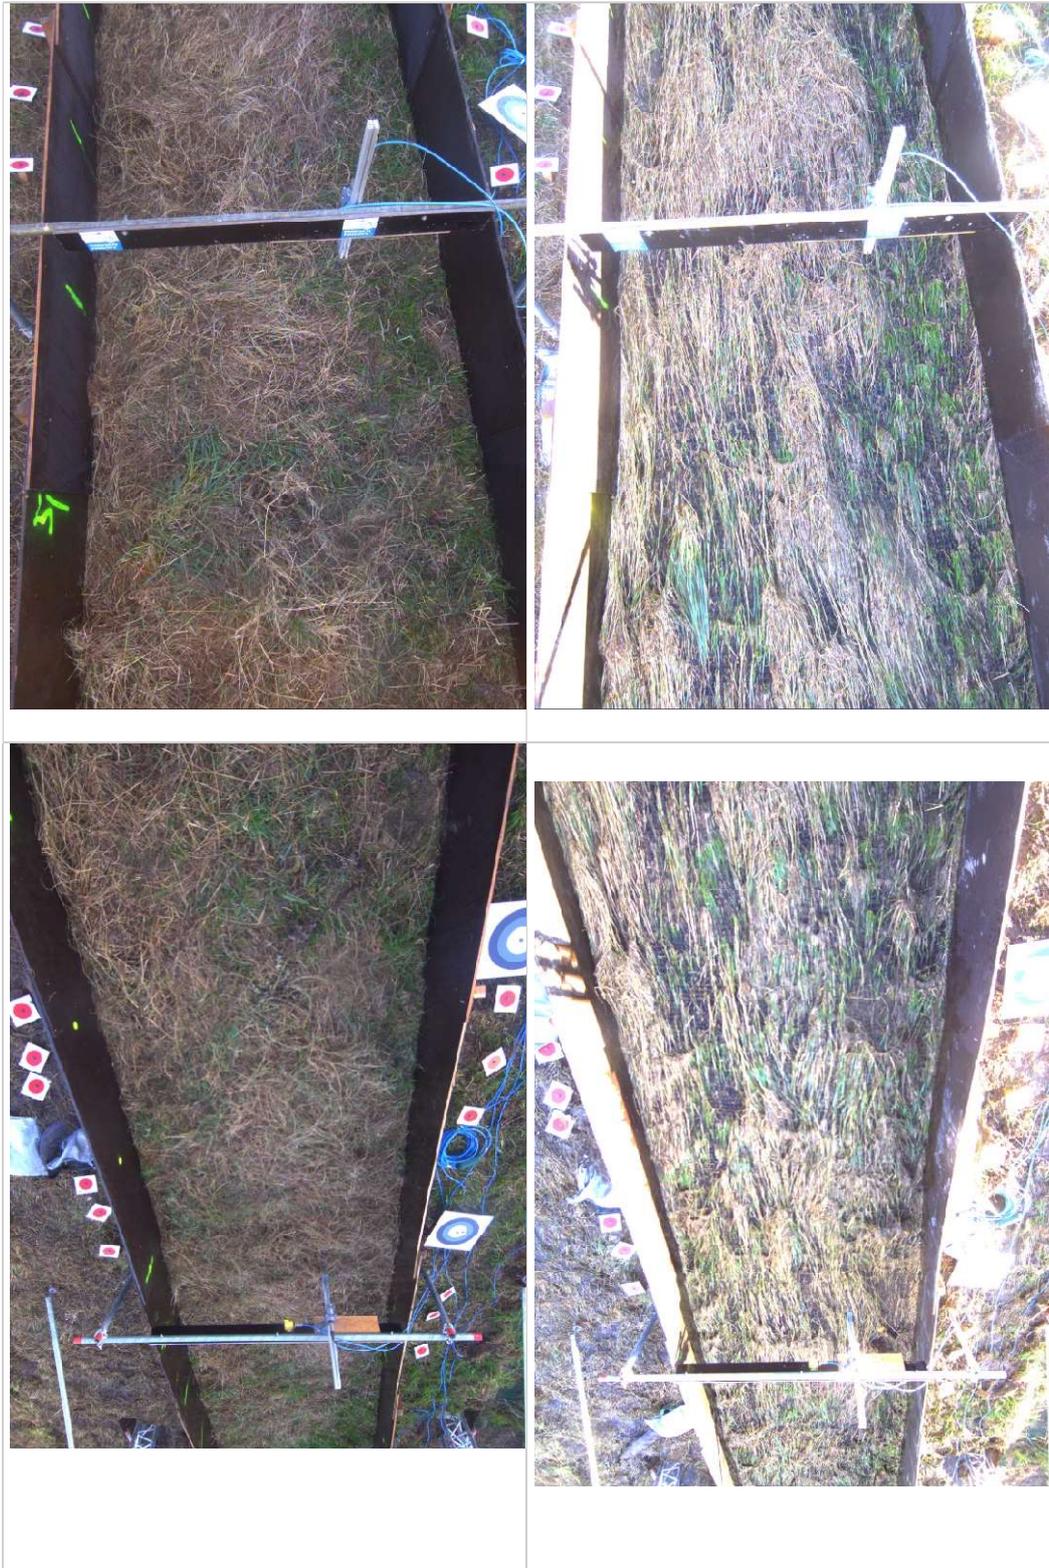
From the onset of the overflow test, it was observed that the water was flowing through and under the RTM solution. Discharge water appearing at the toe was heavily sediment laden, which was an indication of strong erosion below the RTM.

Figure 52: Surface state of N-OF06 before (left; B0) and after (right; B1) the overflow test. Top picture = camera 1; lower picture = camera 2).

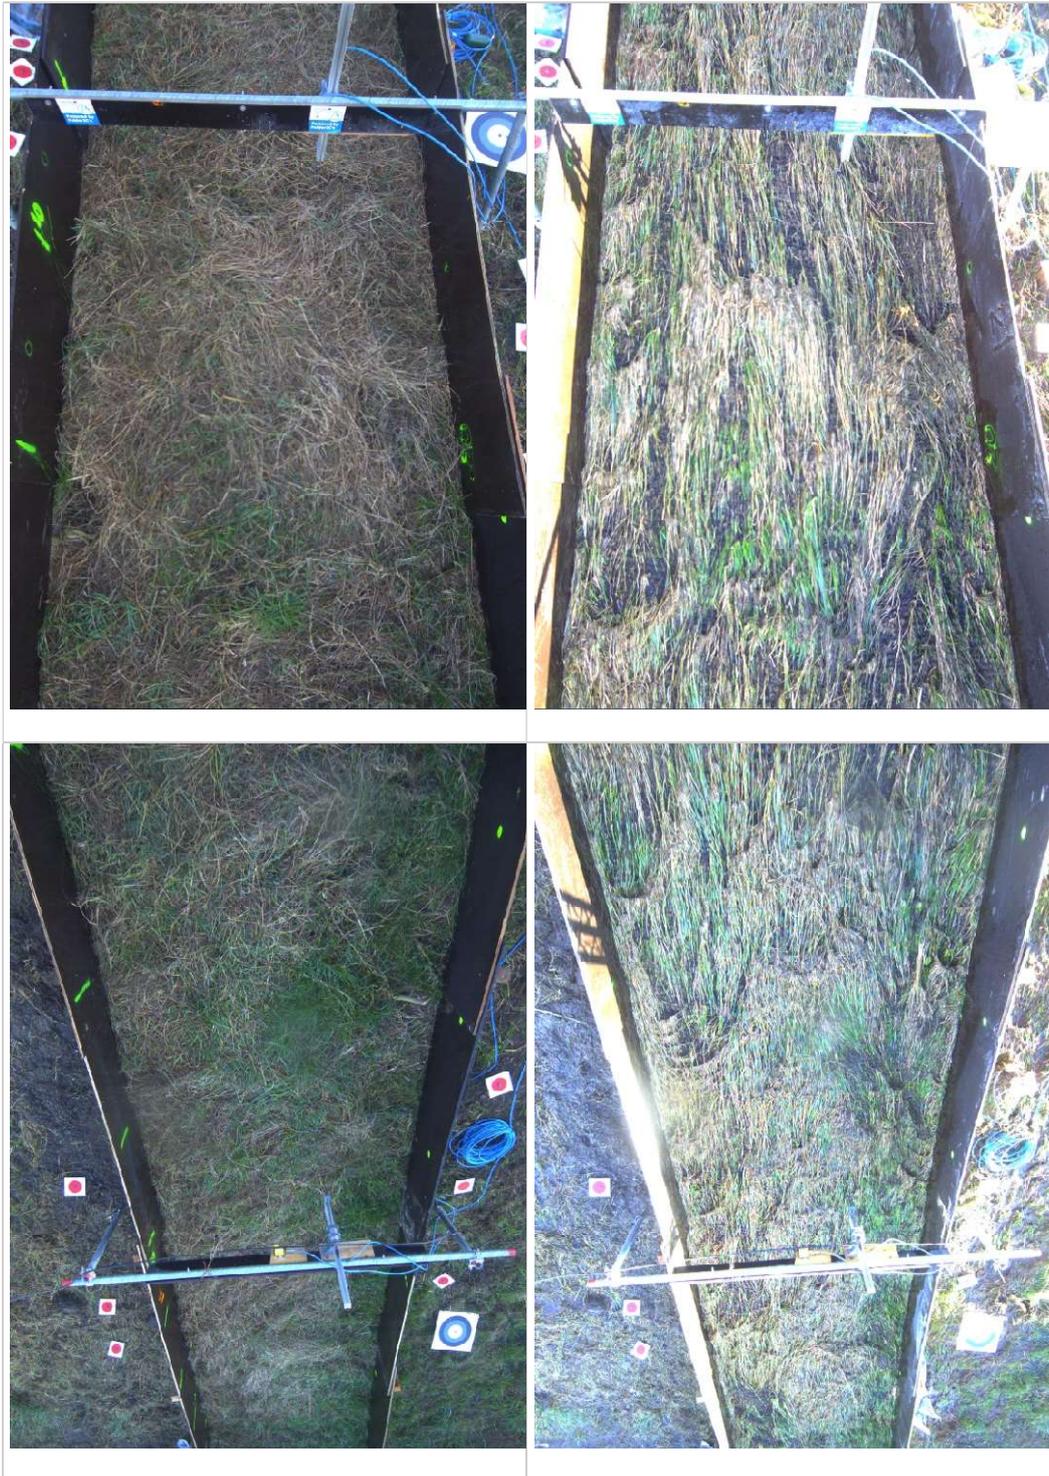
Figure 53: Surface state of N-OF06 before (left; B0) and after (right; B1) the overflow test. Top picture = camera 3; lower picture = camera 4).

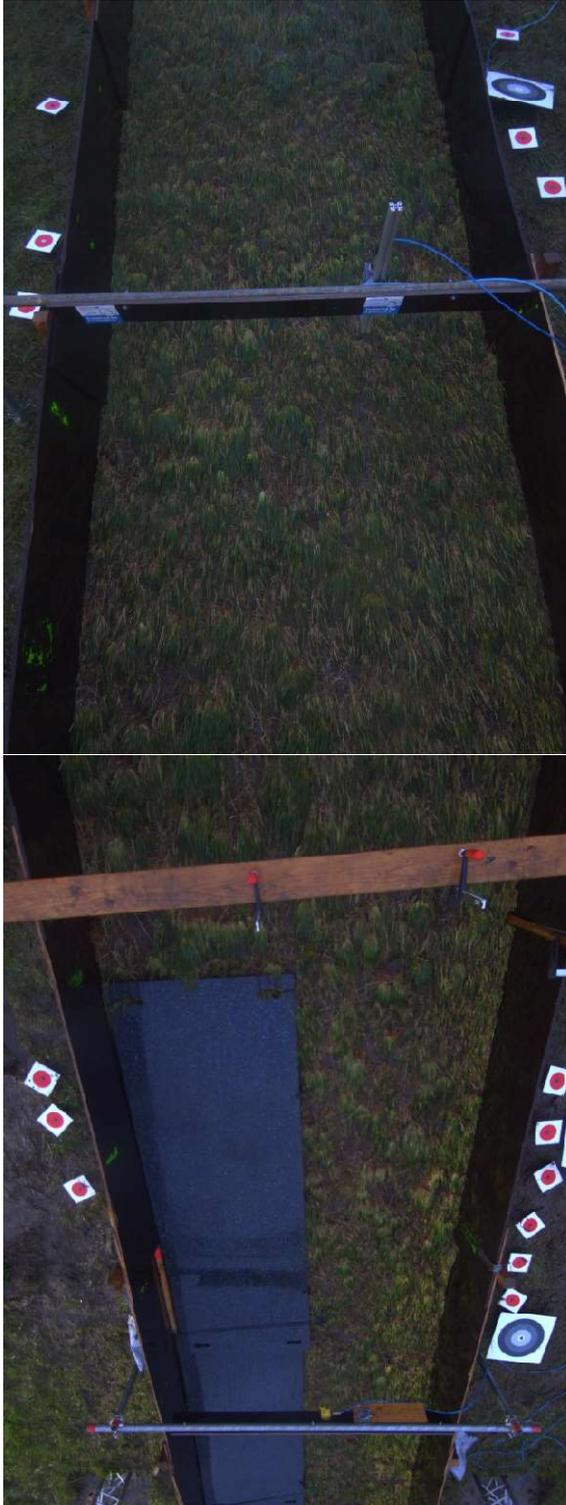
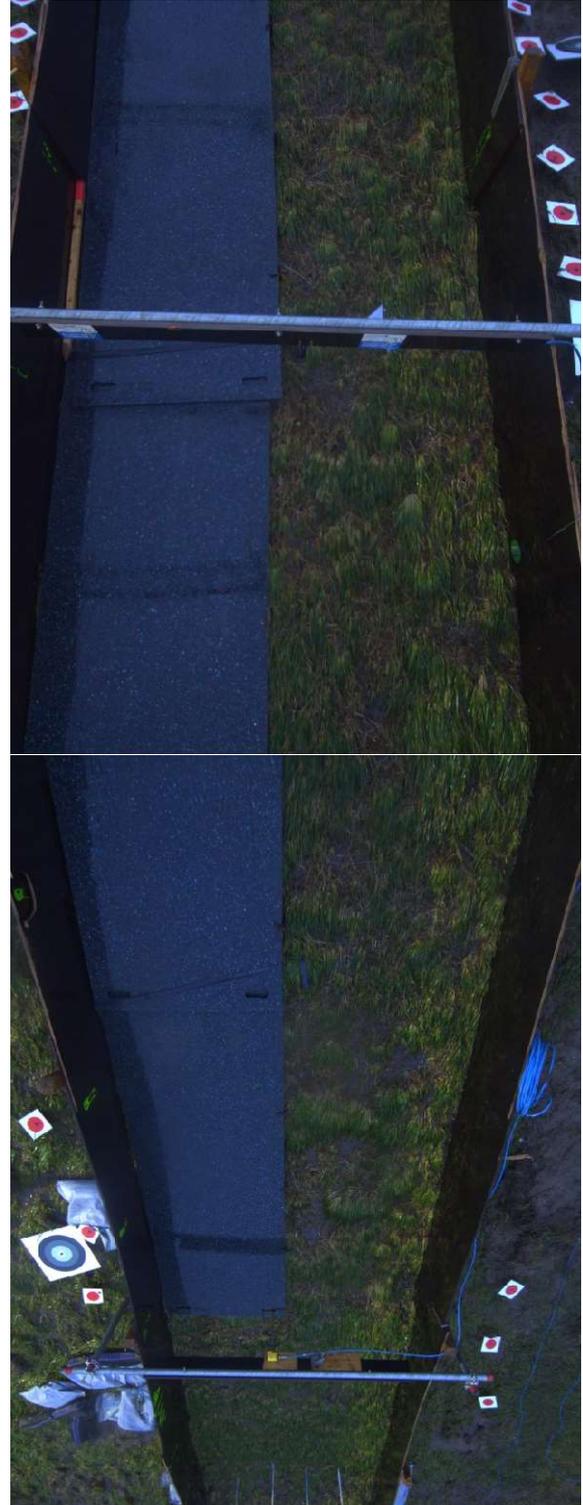
The ERT imaging showed the air-filled burrows and subsequently the filling with water. The cover with plates appeared to have worked well in this specific case as no damage evolution could be observed. Sandbags were put in place as well, but were displaced by the current very quickly.

Figure 63 – Setup of the N-OF09 experiment with protective plates after overflow.

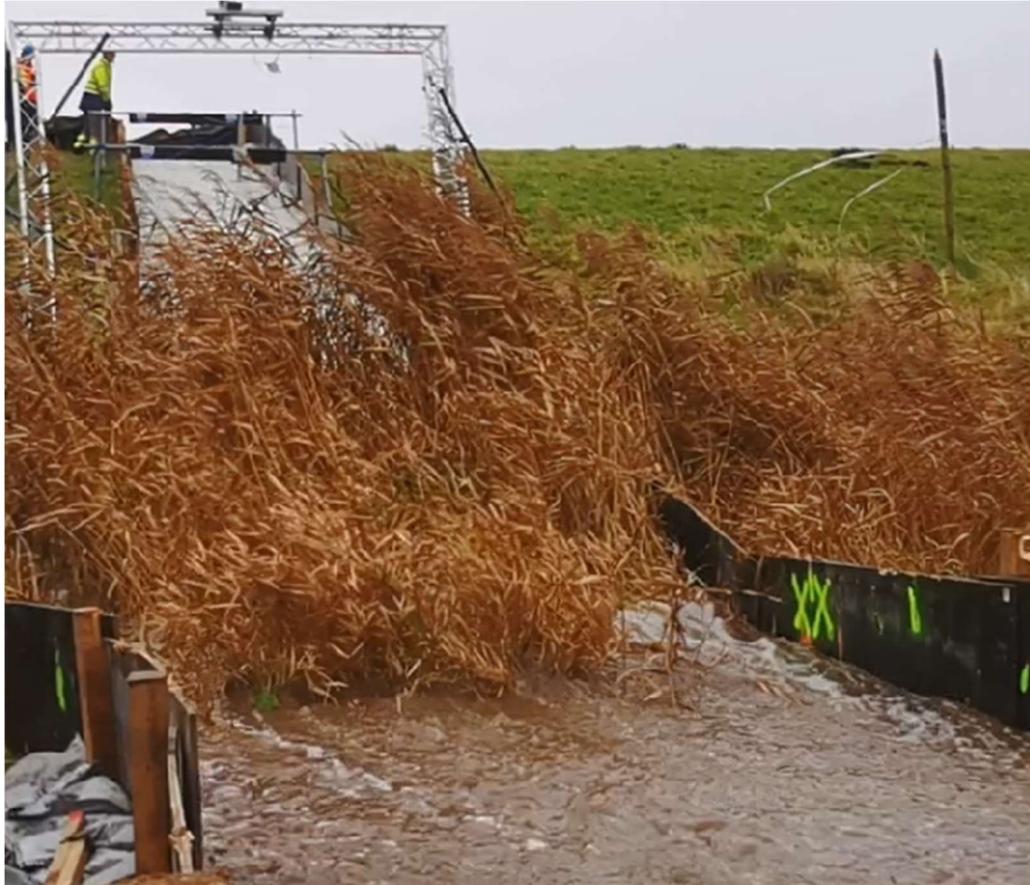
During the overflow test on N-OF10, fast erosion of sediment from between the reed root system was observed. The water seemed to be following “stream channels” in between patches of reed that withheld better against the current. Just upward the reed, longer grass and other vegetation was present and those patches started to loosen quickly and erode. The vegetation layer was being ‘undercut’ by the current so that the vegetation layer started to loosen. Under the loosed vegetation, erosion progressed rapidly (as the soil itself was rather moist and muddy). The sandy inner core appeared was reached quickly, after which sediment outflow

Figure 71: Initial flow over N-OF10 (30 seconds into the test).
