# Overflow tests on Dutch levees

Adaptation  
to climate  
change

## Overflow tests on Dutch levees

1.0 – 20221222

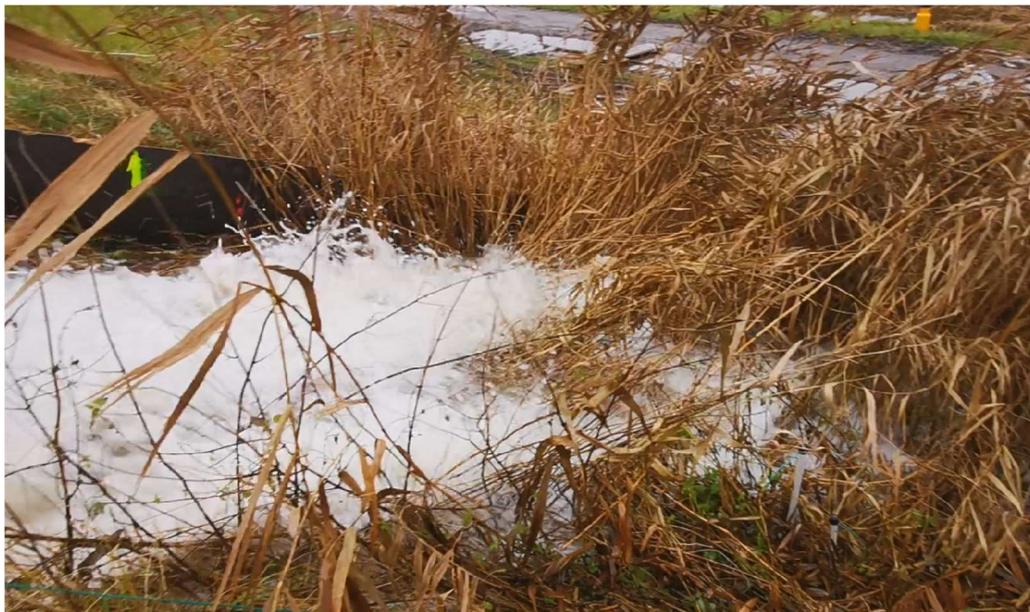
Figure 72: Impact of overflow on the reed at N-OF10.

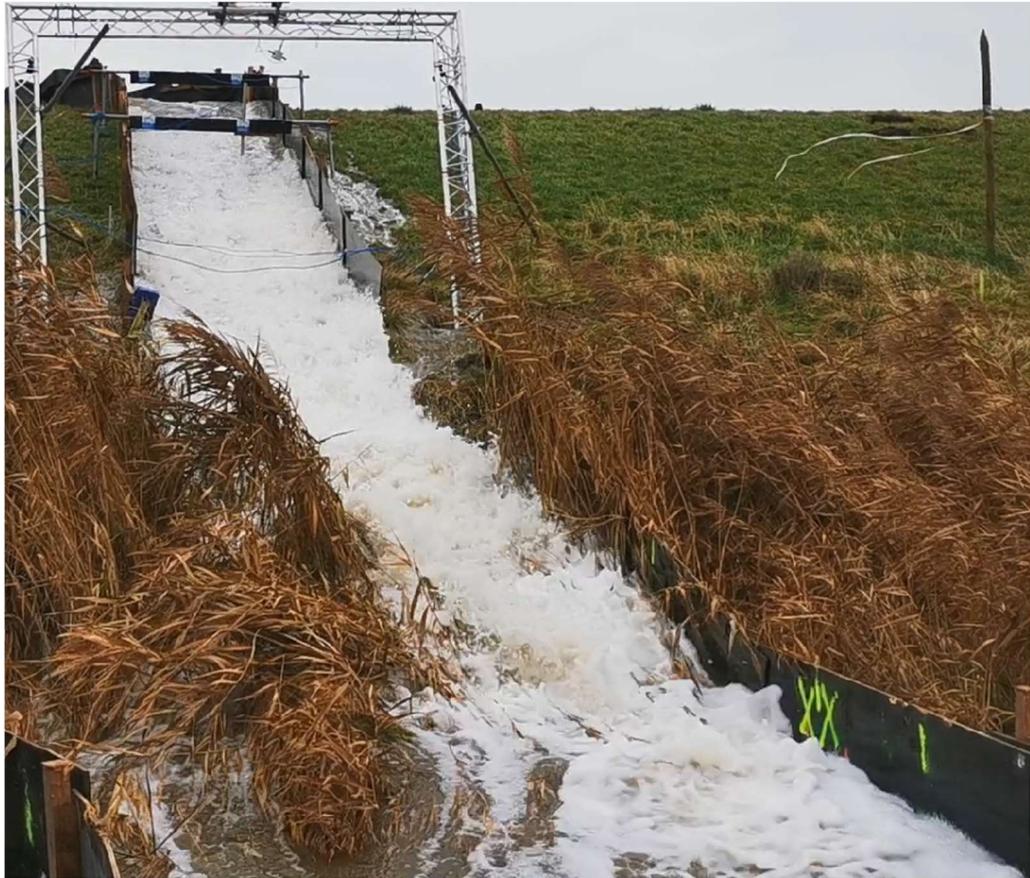
Figure 73: Flow through the reed at site NL-OF10.

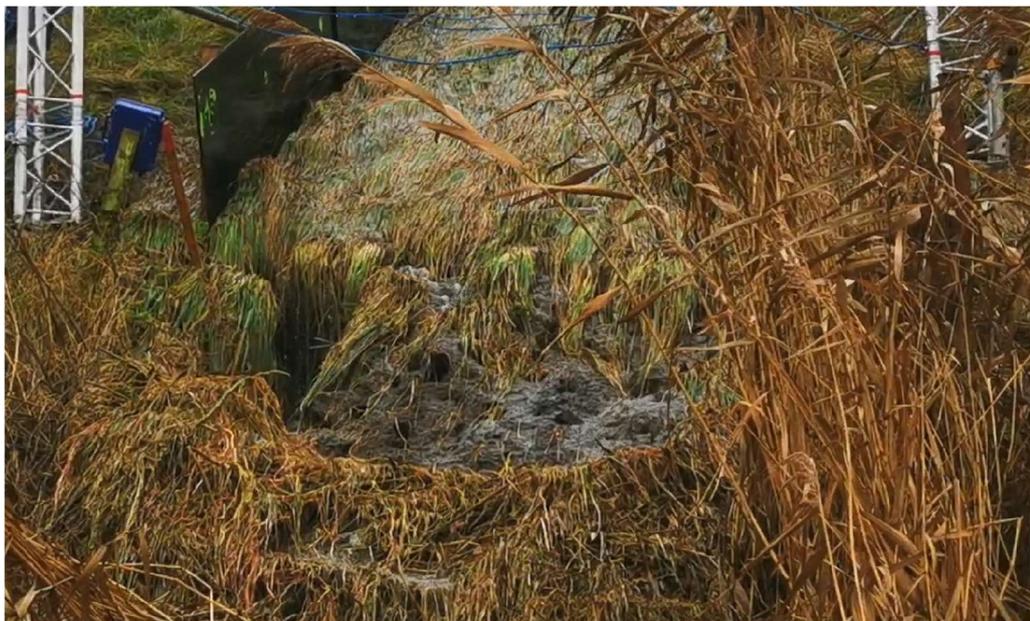
over the toe of the levee was being observed. The experiment was stopped at the moment collapse and cracks appeared in the test section.

Figure 74: Flow through the reed: aftermath of NL-OF10.

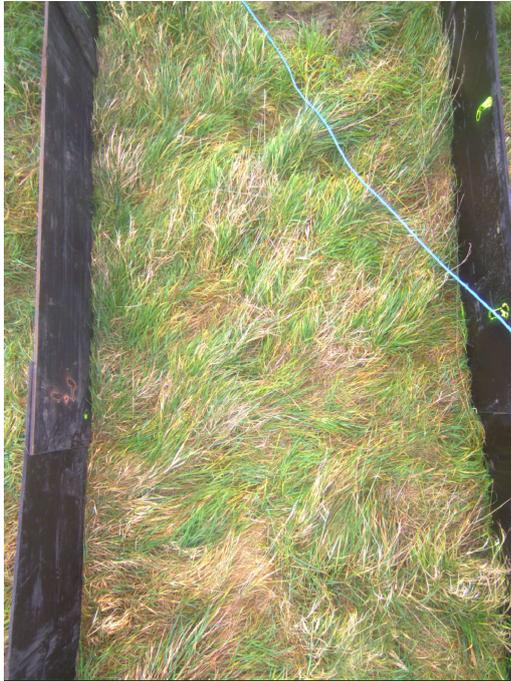
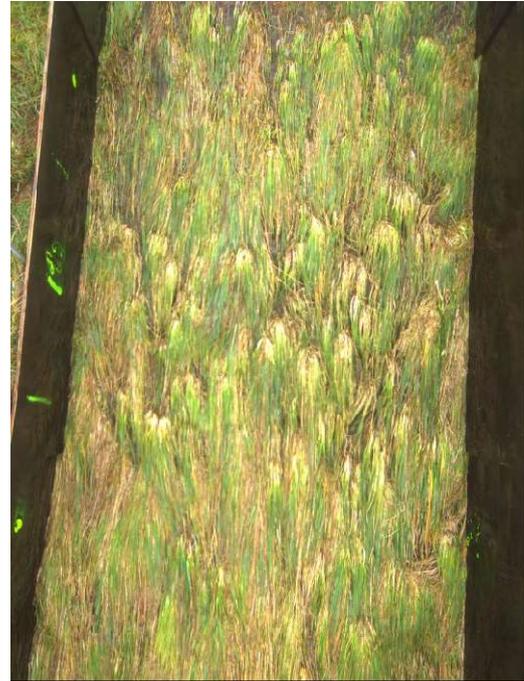
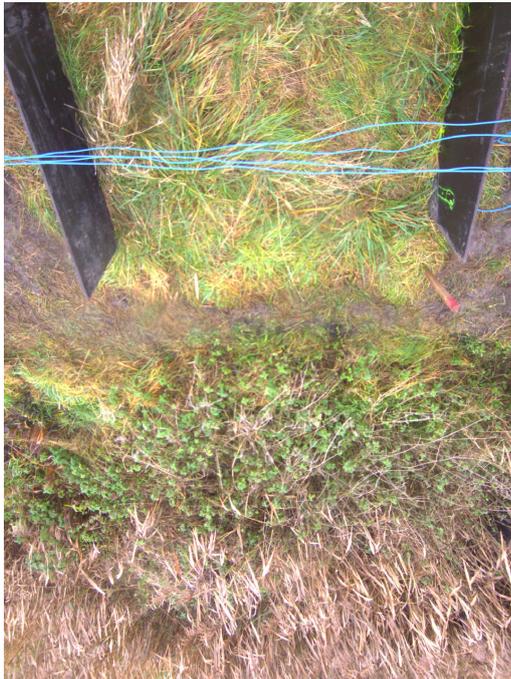
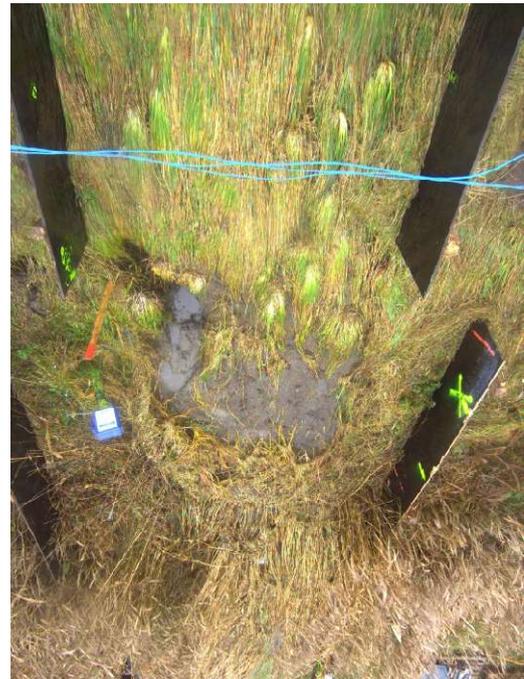
NL-OF10 end state (B1)

Figure 77: Damage state at the start and the end of the overflow test on section N-OF10.

- The presence of a reed on a soft and moist soil patch, does not withstand an overflow event. After little more than 1 hour, significant damage is present.
- The root system of given reed patch does not stabilise the soil in between the roots, but give rise to fast significant erosion.

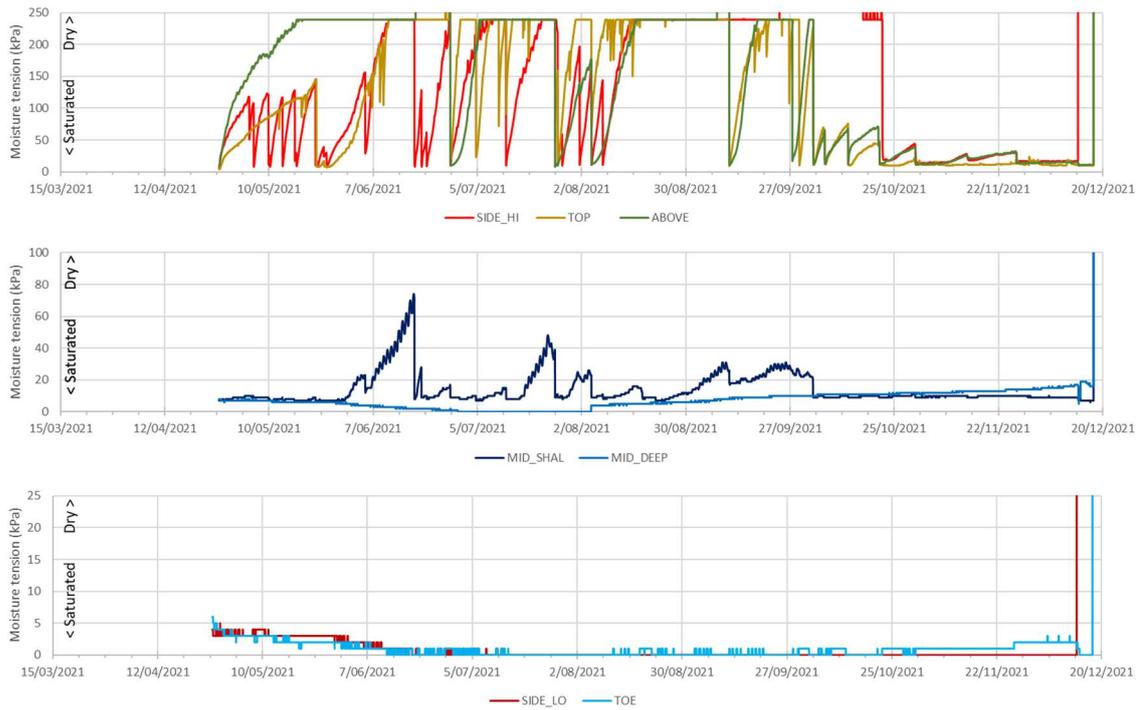
The measurements indicate that the normal surface vegetation layer dries and becomes wet during the months, in response to meteorological conditions. However, inside and at the base of the reed patch, the recordings indicate a continuous wet condition. This supports the visual observation of moist, wet soil in this area, but confirms that water must be present inside the levee structure. The presence of a clogged drain at the toe, would be a suitable explanation for the presence of stagnant water.

Figure 79 -Soil moisture and temperature evolution timeseries.

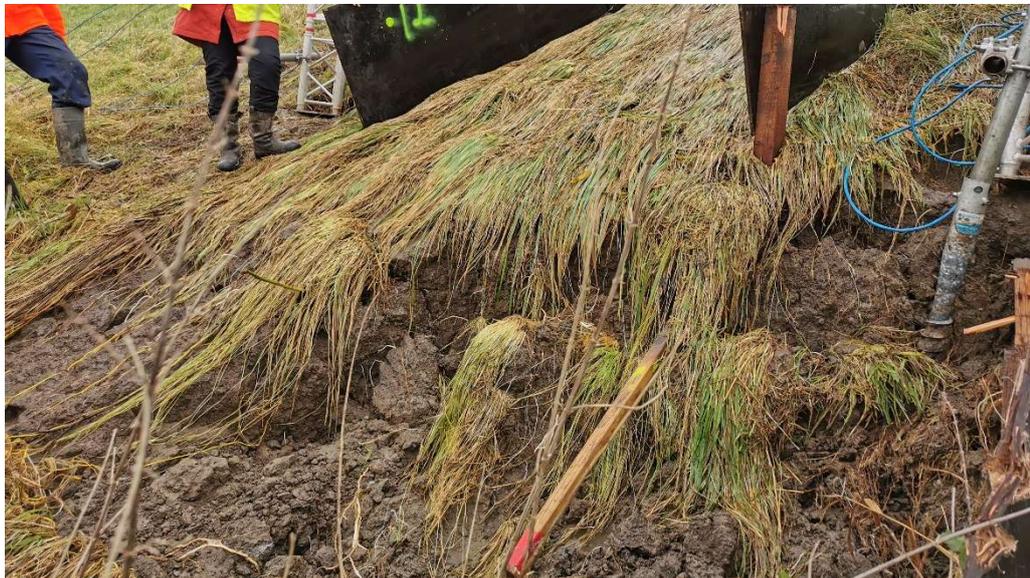
However, due to the pre-existing cracks and cliff formation nearby (N-OF10 test section), the soil destabilizes after +/- 25 minutes and large instability occurs (Figure 85). This evolution started at the side closest to N-OF10 and evolved over the rest of the width of the section. At this point, it is decided to stop further testing.

Figure 85: Outcome of the N-OF11 test after merely 28 minutes of overflow. The erosion on the right side of the picture is also due to the N-OF10 test.

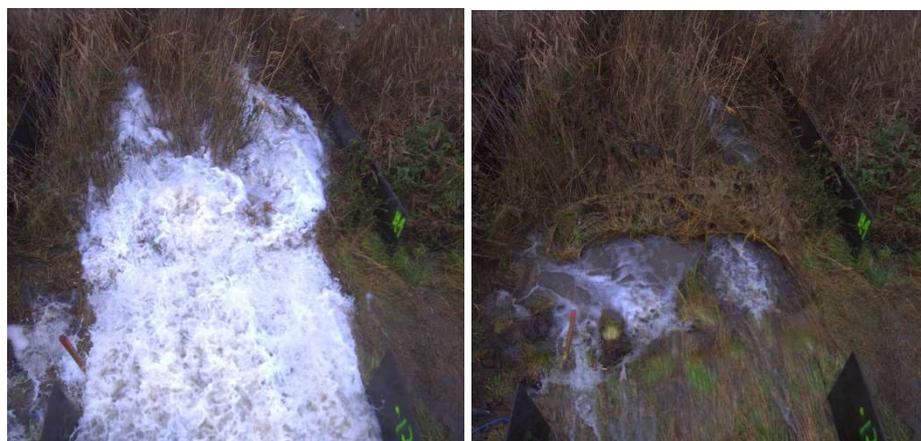
Figure 87: Example of flow patterns at the moment of the collapse (note the outflow on the left of the section) (left, 14:17) and after the overflow event was stopped (right; 14:24)

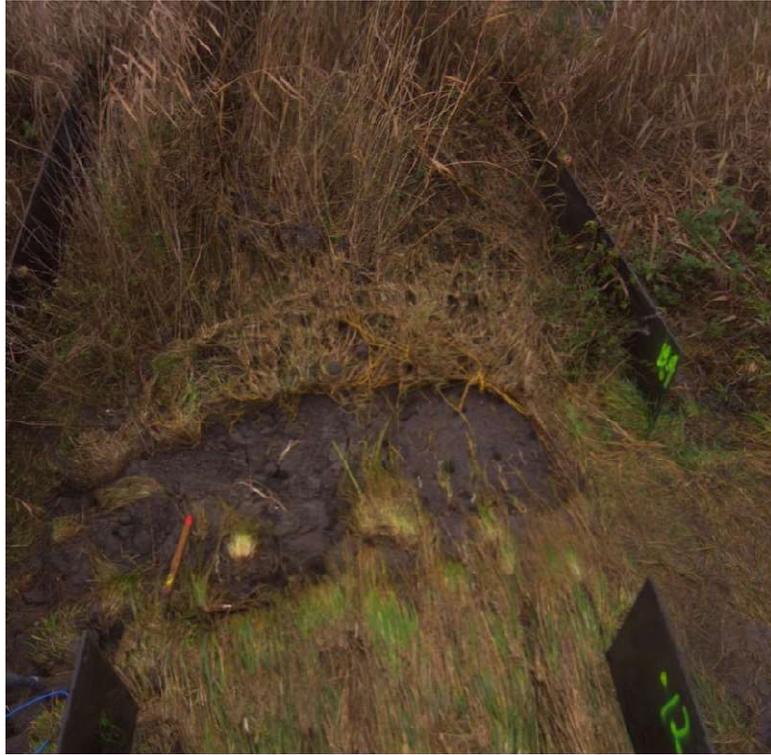
Figure 88: Situation of the high vegetation and reed patch after the overflow experiment (14:30).

- The test on reed section N-OF-11 confirms the findings from test N-OF10.
- The presence of a reed on a soft and moist soil patch, does not withstand an overflow event. After less than 30 minutes, significant damage is present.
- The root system of given reed patch does not stabilise the soil in between the roots, but give rise to fast significant erosion.
