Research on the compliance of the EED

Yordi Boone
Student Number: 68218

Graduation IB 2020: Making Things Happen
HZ University of Applied Sciences

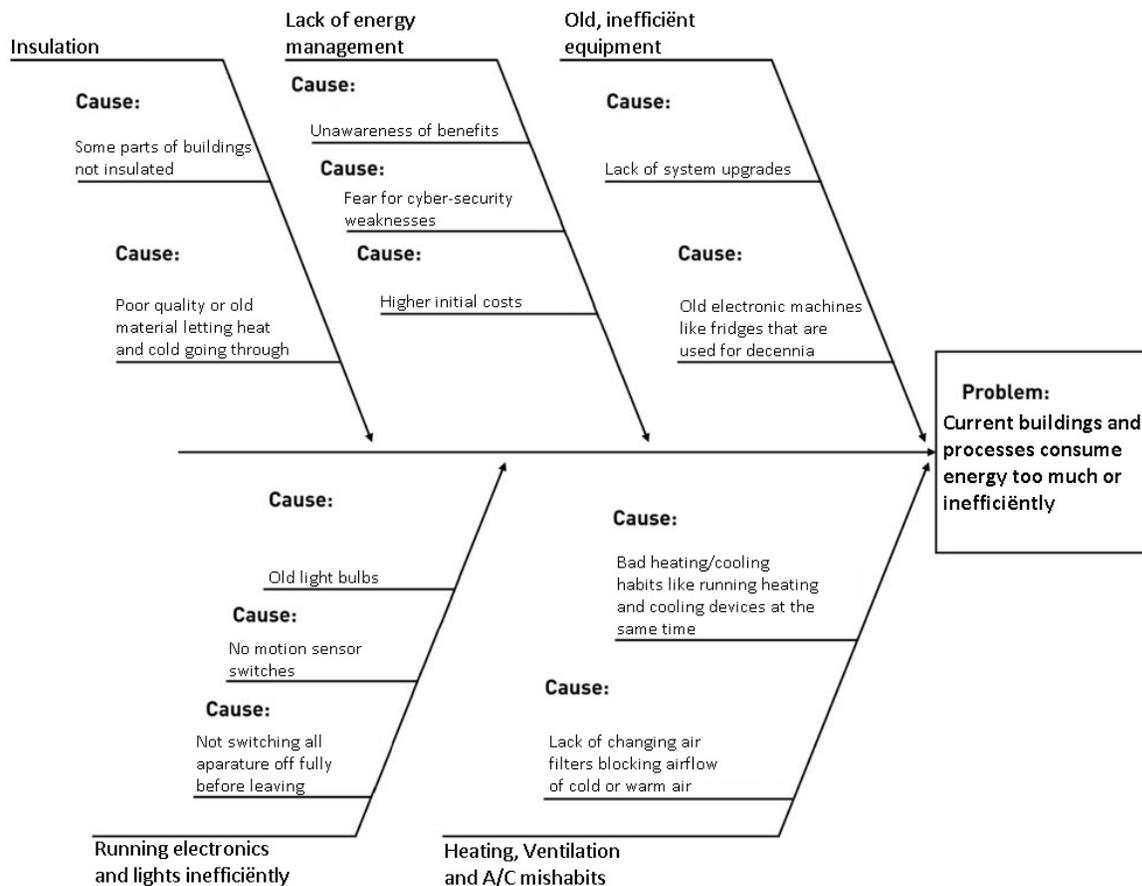
The following figure shows 5 categories which are the possible causes to the defined problem.

Figure 2 - Ichikawa Diagram

The first cause of current buildings and processes consuming energy too much or inefficiently is insulation. This cause is driven by the fact that older buildings used to be less well isolated, since back in the day this was normal. However, nowadays most buildings that are new or recently build are well insulated. Therefore, this tends to be a bigger problem with older buildings. Moreover, insulation that has the minimal resistance lets more warm or cold air through from outside than insulation with more resistance, which leads to the climate system to kick in more often.

The second cause is a lack of energy management systems in a building. An energy management system (EMS) is a system of computer-aided tools used by operators of electric utility grids to monitor, control, and optimize the performance of the generation or emission of energy. Possible causes for this lack of energy management could be that people are scared of extra possibilities to holes in the cyber-security surrounding of the company. Another could be that the benefits of an energy management system are not completely clear or that the people that are in charge of this are poorly informed. Lastly, the cause could also be that the initial costs of equipping this system seem too high for the company.

The third cause could be old and inefficient equipment which is still used or installed throughout the building which are not maintained properly or have not received a system upgrade for a long time, this contributes to devices becoming less energy efficient. Next to this, devices or machines could also be very old. If you look at machines or devices from 20 years ago, these machines consume way more electricity than the same machines nowadays. The reason for this is the ongoing development and improvement of technology and optimization of such machines. Of course, companies are all for the less costs the better, and that is understandable, however, machines like kitchen equipment and printers and such are therefore saved on and not often replaced unless is really necessary.

The fourth cause is running electronic devices and lights inefficiently. This point goes hand in hand with the third cause, however is a different facet to the problem. The sub causes for this cause are old light bulbs equipped in buildings. This causes lights, that burn all day long in offices and such, to be very energy consuming. If old halogen lights are switched out for LED lighting which are far more energy efficient, this will surely be a huge improvement already. Furthermore, having no motion sensors in, for example toilets, will contribute to unnecessary usage of electricity. Also, when employees go home at the end of the day or on a Friday and they forget to switch off certain lights, they will burn for a long time unnecessary. Another cause is a little related but is devices that re not turned off fully which keep consuming electricity or which are in "stand-by" mode and also keep consuming a little electricity.

The fifth and last cause for buildings and processes consuming too much energy or energy inefficiently is heating, ventilation or A/C mis habits, or in short HVAC. What the sub causes for this is for starters running cooling and heating systems at the same time. This could be that in a building a certain employee turns the thermostat higher. In another part of that same building, the temperature rises as well. However, the employee here finds it too warm and turns on the A/C unit to cool the room a bit. This leads to double usage of energy and therefore is very unnecessary and inefficient. Another cause could be that the air filter in the system is not changed regularly, leading to blockage of the system with dust or filth

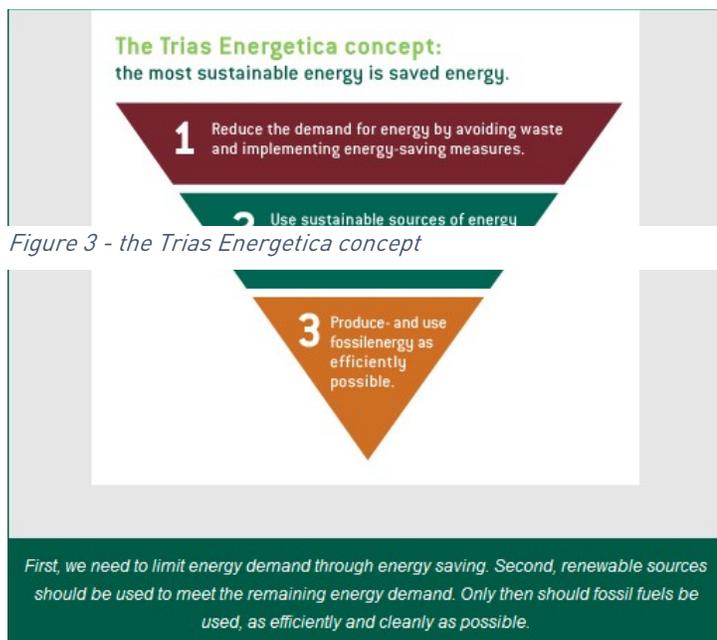
Figure 3 - the Trias Energetica concept

There are multiple researches that zoom in on the more efficient solutions to becoming more energy efficient. Here the Trias Energetica concept is mentioned multiple times (figure 3). This concept consists of three parts that basically present the general steps to take in a most sustainable way to save energy. However, in this research the focus is solely on step one of this concept, which is the reduction of energy demand and avoidance of wasted energy.
